### Introduction:

360° Test Labs has been retained to perform a failure analysis upon provided failed 12V/2.5A battery charger samples, as seen to the right. The label on the chargers identifies them as provided by ..., model #XX-00025(P) 2.5 Amp battery chargers. Each charger also has a round yellow sticker with either a letter N or letter R, and a unique 6-digit number. The purpose of the stickers is unknown, but thought likely to be the client's internal-use tracking number.

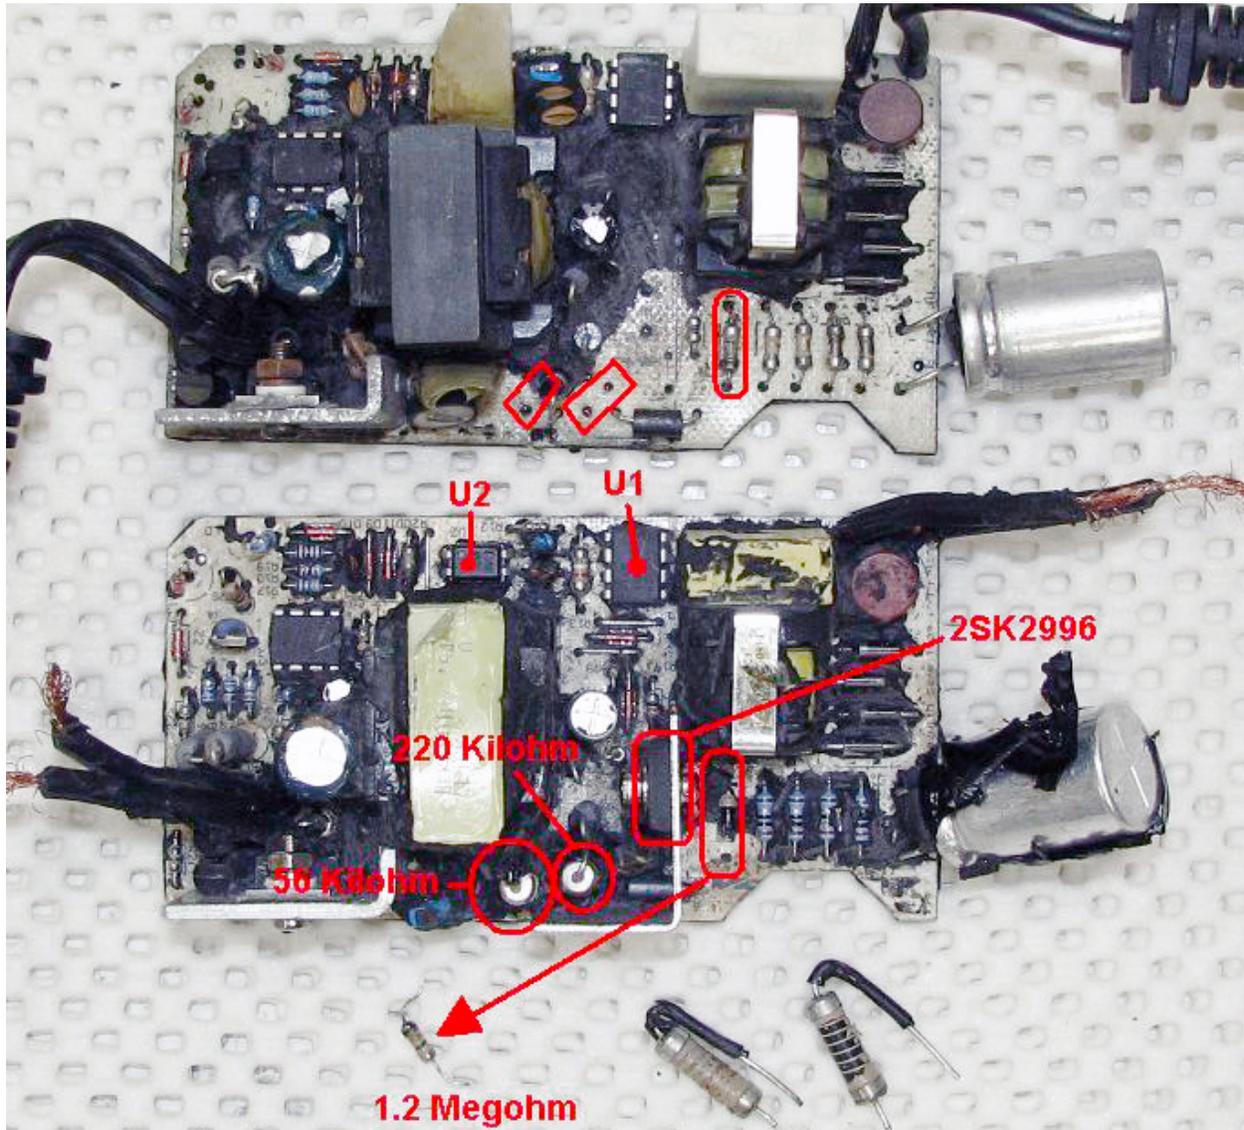
Note that most of the chargers evaluated appeared to have suffered at least two resistor failures, and at least two had all three resistors fail ("fail" being defined as the measured resistance having doubled in value or more).

Further investigation and close examination of the charger with no HV output at all indicates that it most likely suffered lightning damage, as all four bridge rectifiers, and the three resistors, are essentially open; yet, the fuse did not blow. Close examination of the PC board traces shows the solder joints on the PC traces carrying the HV, and the three resistors, appear to be slightly darkened compared to other adjacent solder joints of other parts of the circuitry. This unit has not been de-potted on the component side, so any other damage caused by a lightning strike cannot be discerned, but engineers would not expect to be able to tell due to potting compound residue sticking to components. The following photo shows the location of Ra, Rb and Rc.

U1 is the UC3843BN PWM chip; U2 is an optocoupler which provides feedback between the PWM chip and the output side of the charger. Another 8-pin DIP IC seen on the left side of the boards above is U3, a LM358N dual op amp. Immediately to the left of U3 is U4, a 2.5 VDC programmable reference diode. The 2SK2996 is the N-channel high power MOSFET switching transistor that drives the power transformer on the left side of the board. On the top board, the two red rectangles show where Rb and Rc were mounted; the rounded rectangle to the right is the 1.2 megohm resistor Ra. The two large resistors seen on the work surface below the lower pictured board were removed from the upper pictured board; the smaller, ¼ watt resistor was removed from the lower board.

Additional work on all repairable units has restored five units to apparently-proper working condition by the replacement of various resistors. In addition to the three resistors previously mentioned (Ra, Rb and Rc), a 2.4 kilohm (probably rated at 1/6<sup>th</sup> watt) resistor in the output regulator was found open on at least three units. It is possibly noteworthy that all three of these units did NOT have an outright input resistor failure, however (although the values of several of the input resistors appeared to be somewhat off, such as 1.9 megohm on unit I076908 and 2.2 megohm on unit I077545). Other units found with open input resistors were repaired by replacement of the failed resistors.

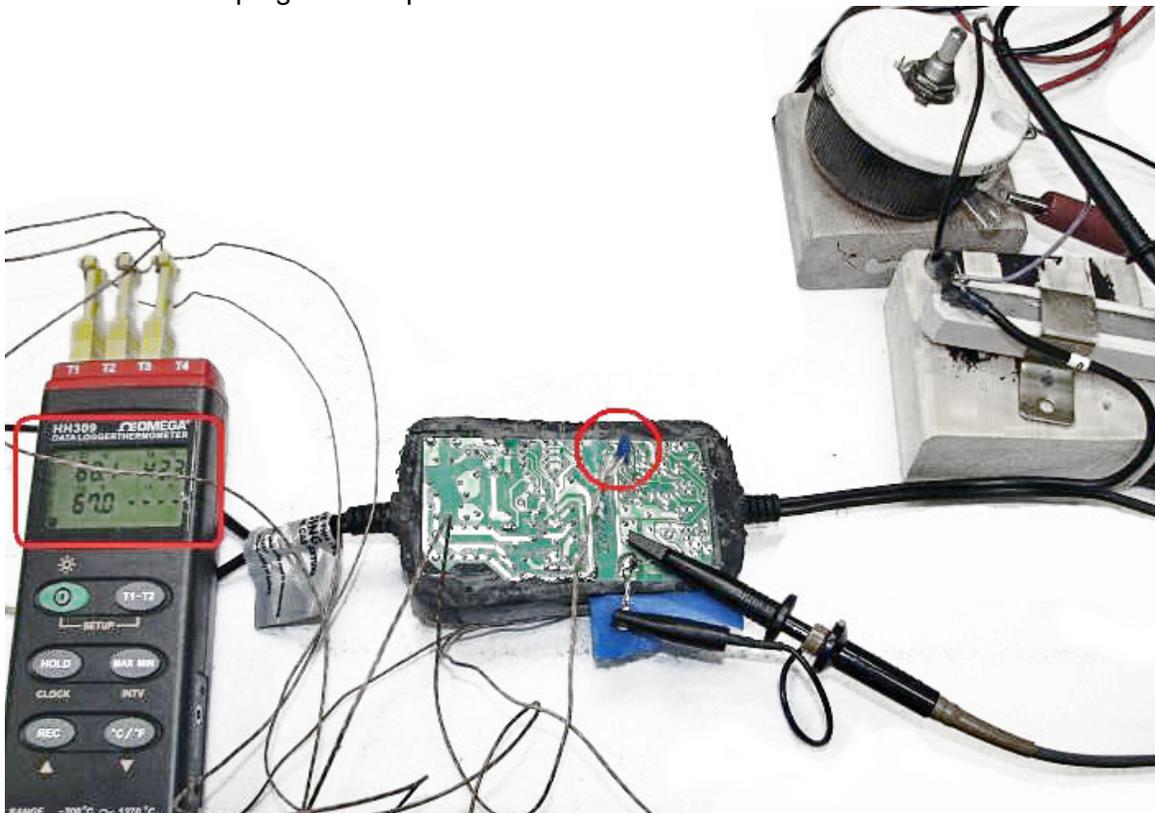
The 2.4 kilohm resistor failures might be explained by consideration of the power dissipated. This resistor drops the Vcc voltage of about 13 VDC (when the charger is working properly) to 2.5 VDC for the reference diode, U4. Thus, there is approximately 10.5 volts across the resistor. Ohm's law says the current through the resistor is thus about 4.4 milliamperes, so the power dissipated is about 46 milliwatts.

However, the resistor is mounted flat on the PC board and obviously gets no cooling other than conduction through the potting compound. Typical data sheets for both carbon film as well as metal film resistors state the resistors are rated to be able to operate at full power to 70°C. At 100°C, they should be derated to about 66%, and to 50% at about 110° C.

The unit under test is shown in the following photo. The datalogger thermocouple thermometer display (red-rectangle highlighted) shows from left top, left down, then right top: 68.1°, 67.0°, and 43.3°, all Centigrade, for the top of the charger case (laying on the table), the side (held on the case by blue tape), and the 2.4 kilohm resistor (barely visible in the red circle). The load resistors are at the top right of the photo.

Thus, it is quite possible that the 2.4 kilohm resistor could be overheating and so opening up.

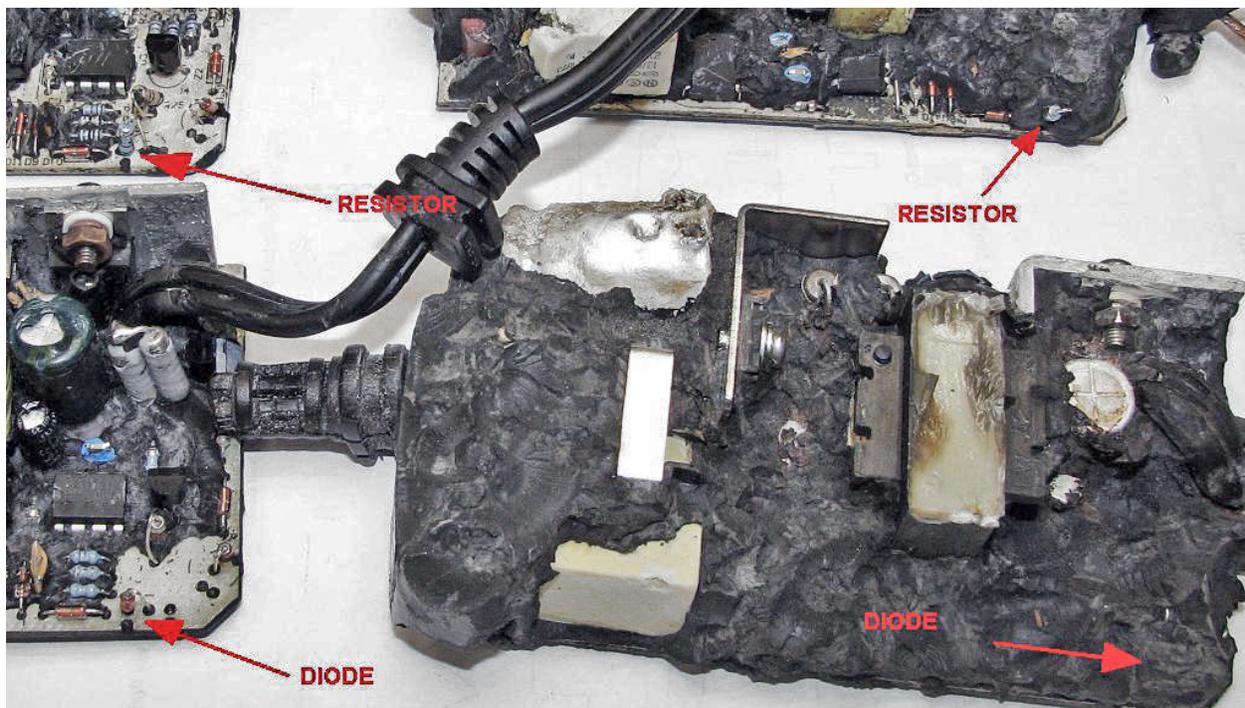
Engineers found at least two of the chargers appear to have 51 ohm resistors installed on the output side of the chargers in series with diode D10. However, 10 of the 12 de-potted chargers appear to have a diode installed in this location on the PC board (this is noted on the schematic). Engineers do not know the cause or significance of this change. The units with resistors are the unit de-potted by Cliient (whose serial number is unknown to 360°), and unit I076945 (serial number indicates it was manufactured during the 19<sup>th</sup> week of 2009). The following photo shows the location of these parts.

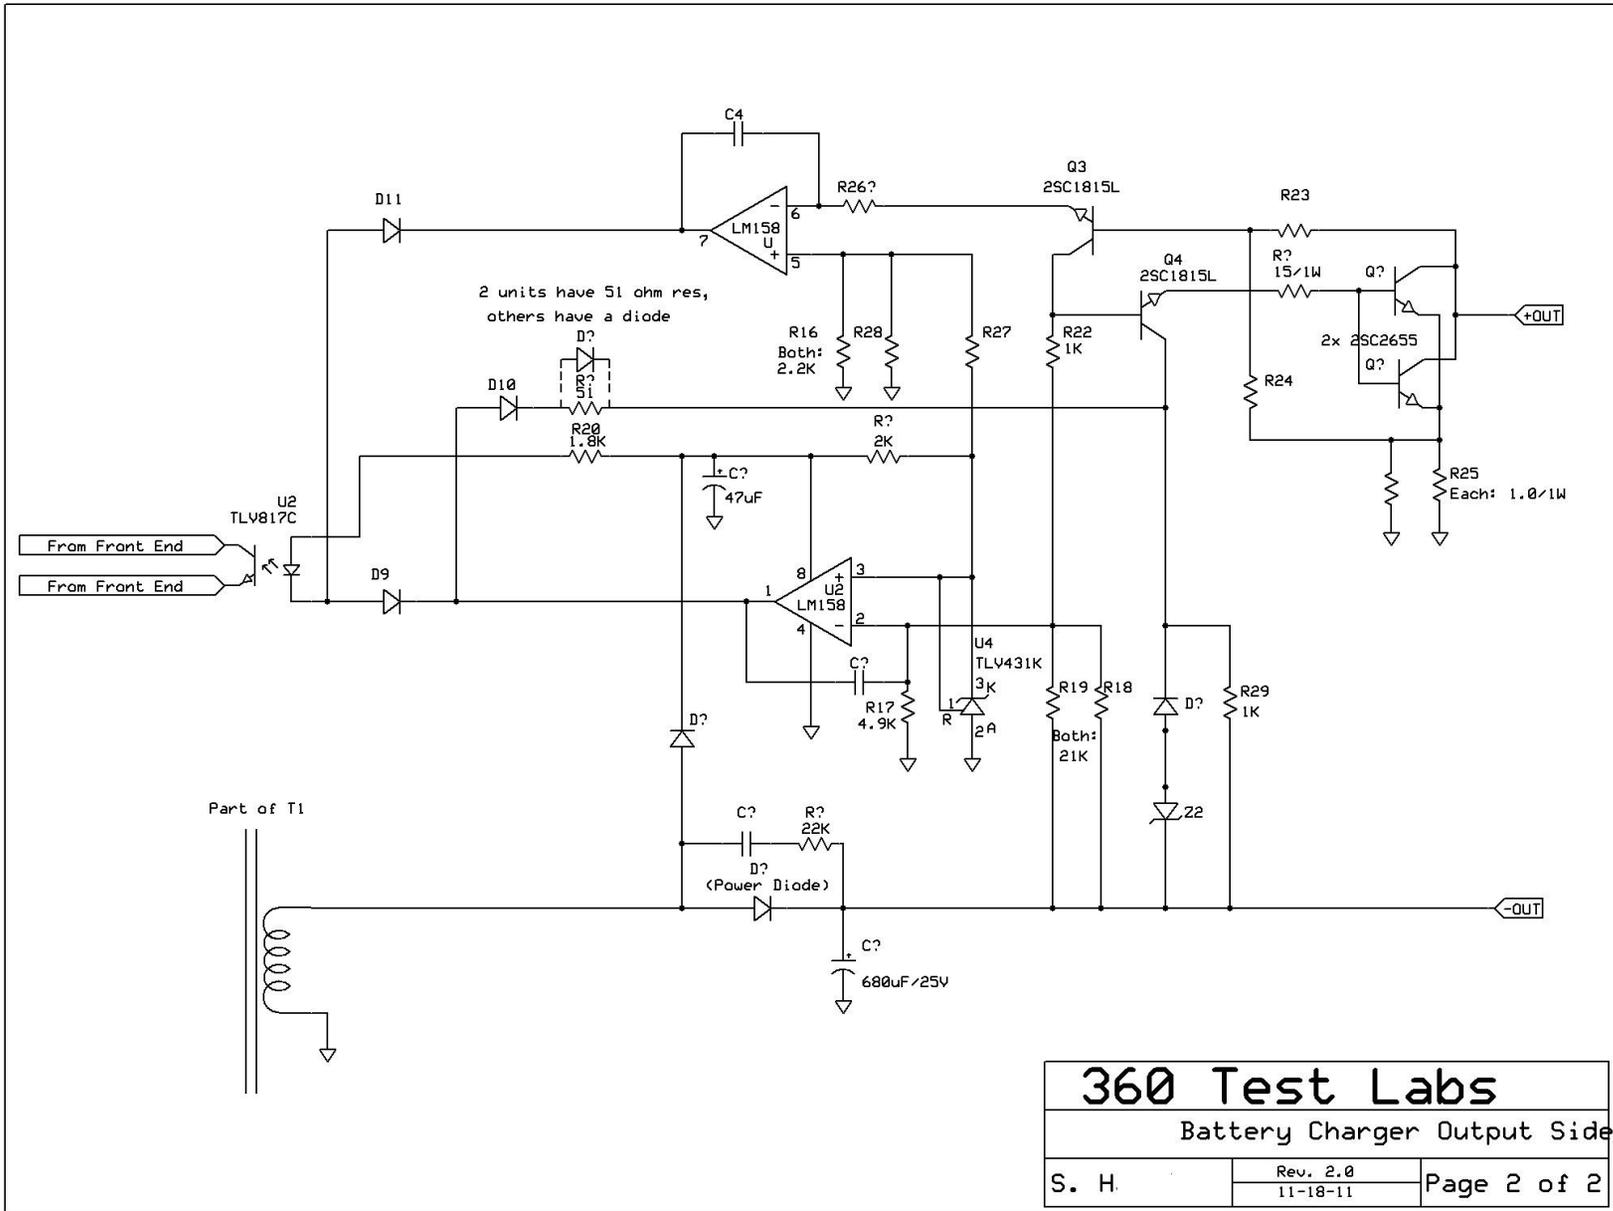
**Developed Front End and Output Side Schematics Follow**

The schematics attached at the end of this report have been drawn by 360°'s engineers based upon what can be seen on the PC boards of several units that have been mostly de-potted. Where possible, resistor values were determined by measurement and confirmed, where possible, by examination of the remnants of color bands on de-potted resistors. Capacitors generally, however, will have to be measured as any markings have been obscured by the potting or de-potting compounds.
