## Introduction:

360° Test Labs has been retained to ascertain whether certain circuitry changes to fluorescent lamp electronic ballasts reduce or eliminate an overheating problem whereby a plastic shroud over the lamps melts at the ends of the lamps.

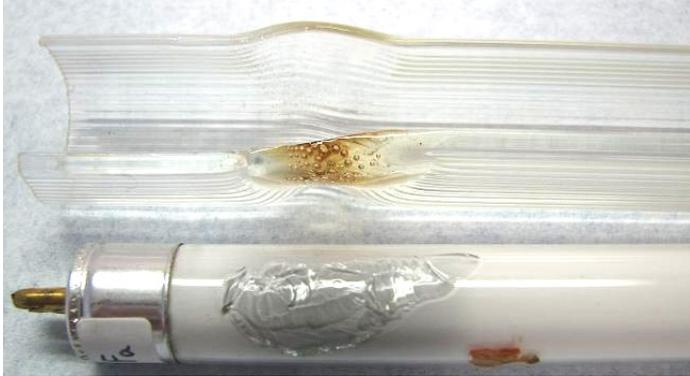
At left is fixture 5F (all the failed fixtures were named 1F through 7F to keep lamps, shrouds and fixtures together with their original parts).

Note the appearance of chipped glass; on all bulbs showing this chipped area, this portion of the bulb was in direct contact with the brown, burned spot of the plastic shroud.

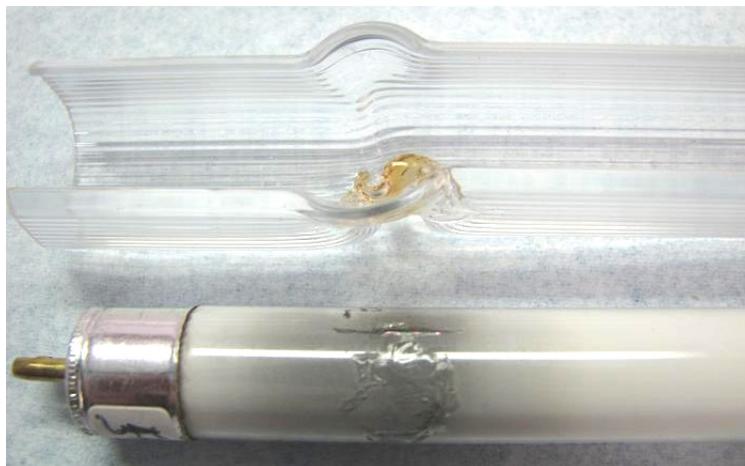
At left is fixture 7F, with the same chipped glass appearance but in addition, an obvious crack in the glass envelope.

The plastic shroud was completely melted onto the glass of this bulb and was difficult to remove—and was possibly the catalyst that caused the this crack.

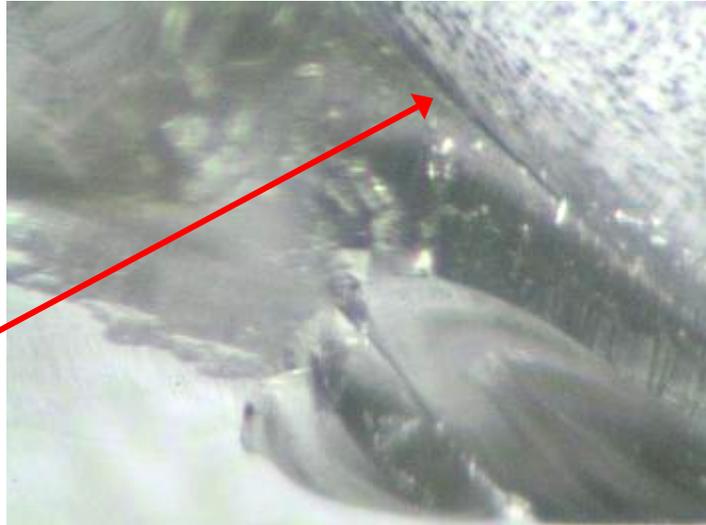
The failed tubes exhibited what appeared to be chipped glass at the areas where the plastic shroud had melted. However, closer examination under the microscope reveals a swirl pattern characteristic of melted glass, as seen in the photo to the right.

Melting can be seen as the line running from top right-center of the photo, to the middle of the right edge of the photo.

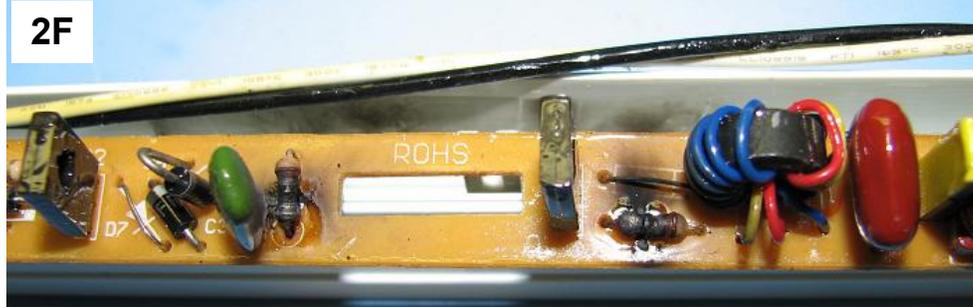
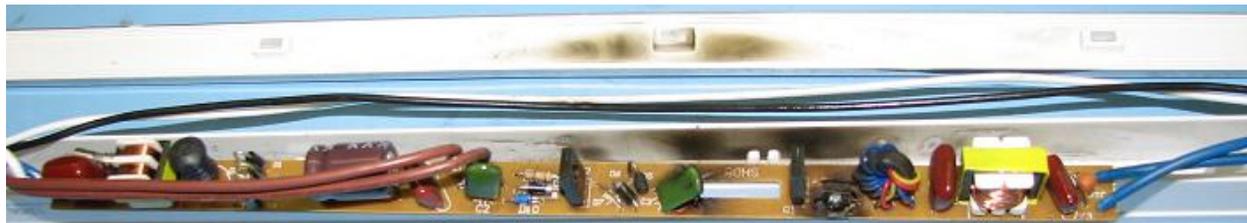
Two fixtures had burned electronic parts on the PC board, as well as their 1-ampere fuse having been opened, apparently due to overcurrent. The fuses on fixtures with no burned parts were all

found good and those fixtures worked again once the tube was replaced. The picture below shows the burned components on fixture 2F.

Fixture 5F is shown above; note the smoke smudges on the top cover of the fixture case. The same resistors were burned on this PCB as found on fixture 2F's board.

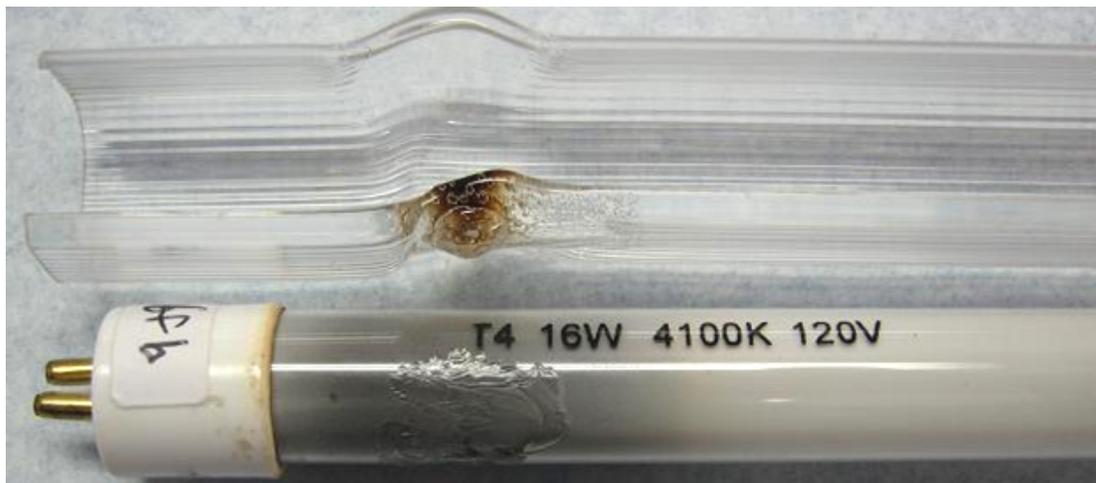
Fixture 6F was found with a late-type bulb installed – with white end caps; all the bulbs in the other six fixtures had bright aluminum end caps. Besides the different end caps, the light “color” of the white-cap tubes is stamped 4100K on the tubes as seen below, whereas the “color” of the older tubes is 3400K. This white-capped tube, shown in the photo below, exhibits the same chipped-glass failure mechanism as the older aluminum end-cap tubes.

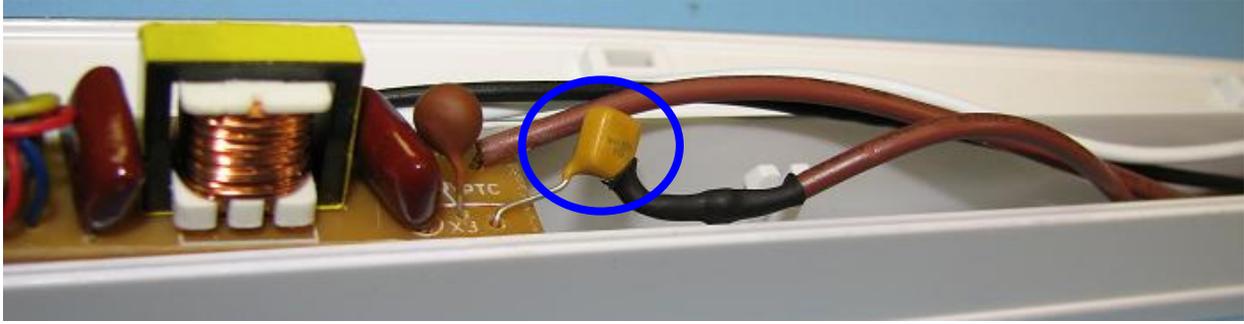
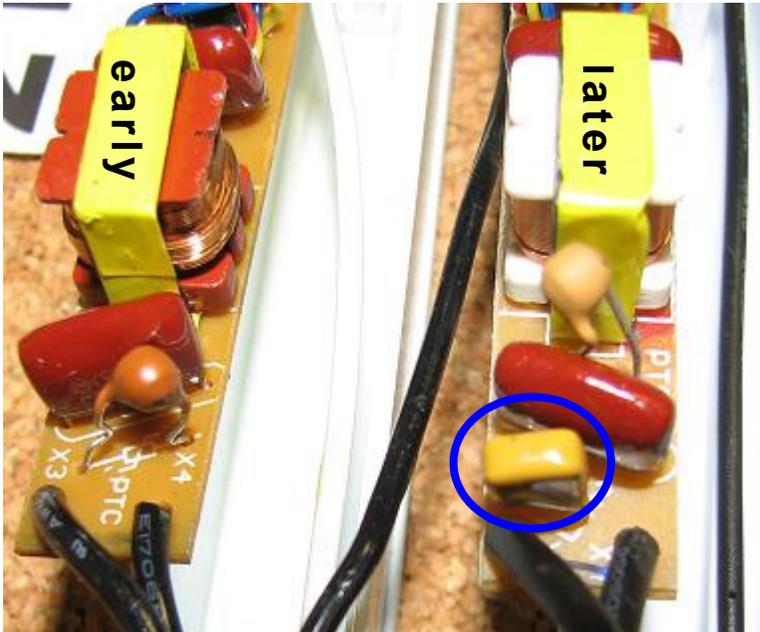
Fixture 7F was found to have been modified at some time by the addition of the same PTC that has been permanently added to all the new fixtures; yet, it's tube still got hot enough to melt the shroud, as seen in the picture above of fixture 7F. The below picture illustrates how the PTC was added to fixture 7F. It is not clear whether this wiring technique is NEC-compliant. However, since the fixtures have plastic cases, there is no danger of this wiring technique shorting.

At left, the photo shows a PC board from an early fixture (left side fixture), with only a high voltage-circuit (HV) PTC. To its right is a late-date code fixture's PC board with both the original HV PTC as well as the added filament PTC. The new PTC is the brownish-orange small rectangular object just above the black wires on the right-hand PC board. The small round brown object above the darker brown oval-shaped capacitor is the high voltage PTC, which is present in all the fixtures. This HV PTC protects the electronic ballast in case the tube will not ignite by increasing its resistance until the multivibrator will stop oscillating.

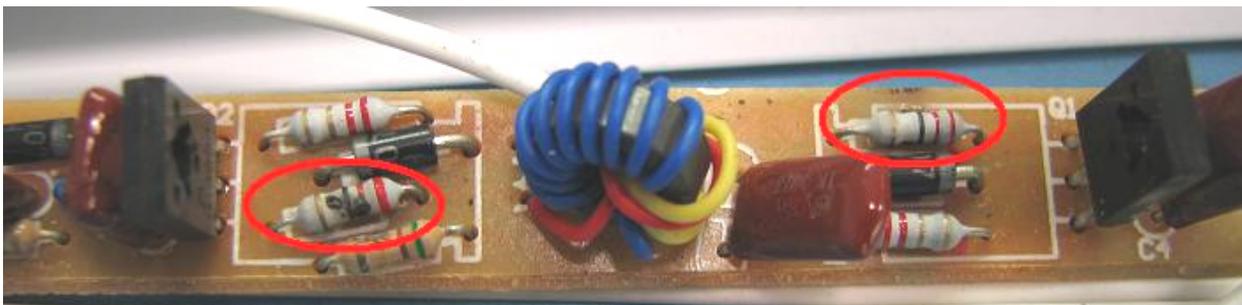
After approximately 3 hours operating continuously at 175 VAC, one 240 volt fixture failed catastrophically, the first such failure; see the photo below.

In this case, it appears that the two multivibrator transistors either overheated or the high AC input voltage exceeded their voltage ratings. One of the transistors failed internally, causing its

associated base current limiting resistor to almost instantaneously burn open, then the other transistor also failed and took out its own base resistor. The two red-circled resistors above show almost no damage other than several small specs of black soot where they instantly burned open. In addition, the edges of each transistor were also sooty, indicating they, too failed almost instantaneously.

The electrical design of the 240 volt ballasts is similar, but not identical, to that of the 120 volt ballasts; one difference is the addition of 0.22 Ohm current limiting resistors at the emitter of each transistor, which can be seen in the photo above (the two devices with the red color bands next to the circled resistors).

The 120 volt ballast design does not contain these emitter current limiting resistors. The failed base resistors shown above perform the same function as R3 and R4 in the 120 volt ballasts, which were the two resistors found severely burned on two of the seven failed fixtures that were provided to 360° Test Labs. However, the similarity of this failure mode between the earlier-failed fixtures and this “surge”-induced failure is likely only that: a similarity.

Note, for example, that the earlier resistor failures evidently occurred over a period of time during which the resistors did not instantly fail, which was the case above where the resistor did not have time to actually burn. In this case, it appears much more likely that the cause of failure was the transistors breaking down due to the high AC input voltage whereas the earlier failures appear to be related to a failure of the fluorescent bulbs, which the multivibrator’s two transistors kept trying to ignite until the transistors overheated and shorted internally.

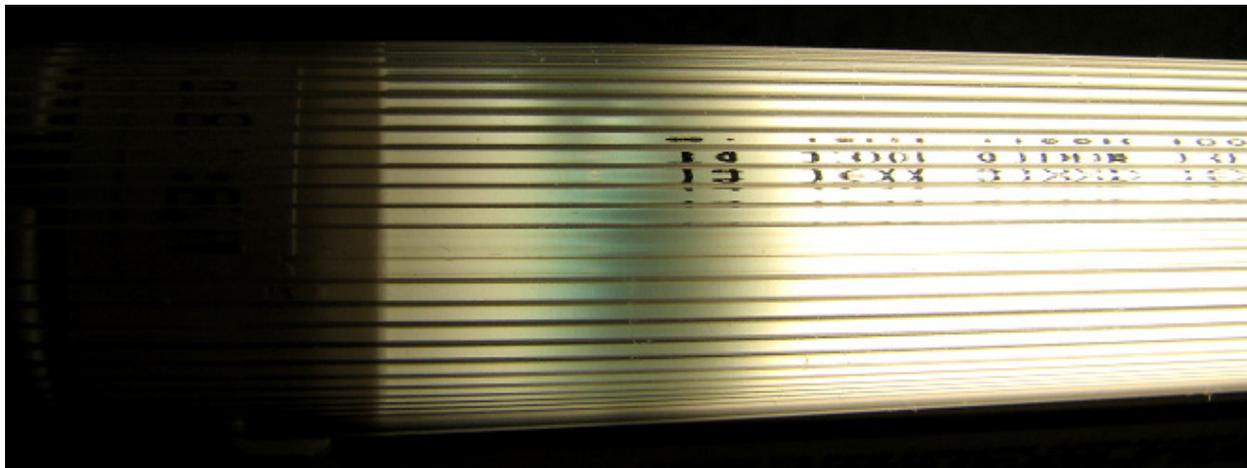
During the 160 VAC test, it was noticed that several tubes showed a slight blue color at either end, as seen in the photo below:

It is unknown what the bluish color signifies, if anything. When tests were first begun on new fixtures, several bulbs exhibited a similar blue or violet glow near the filament but as the end of the tubes darkened, the glow became less visible.
