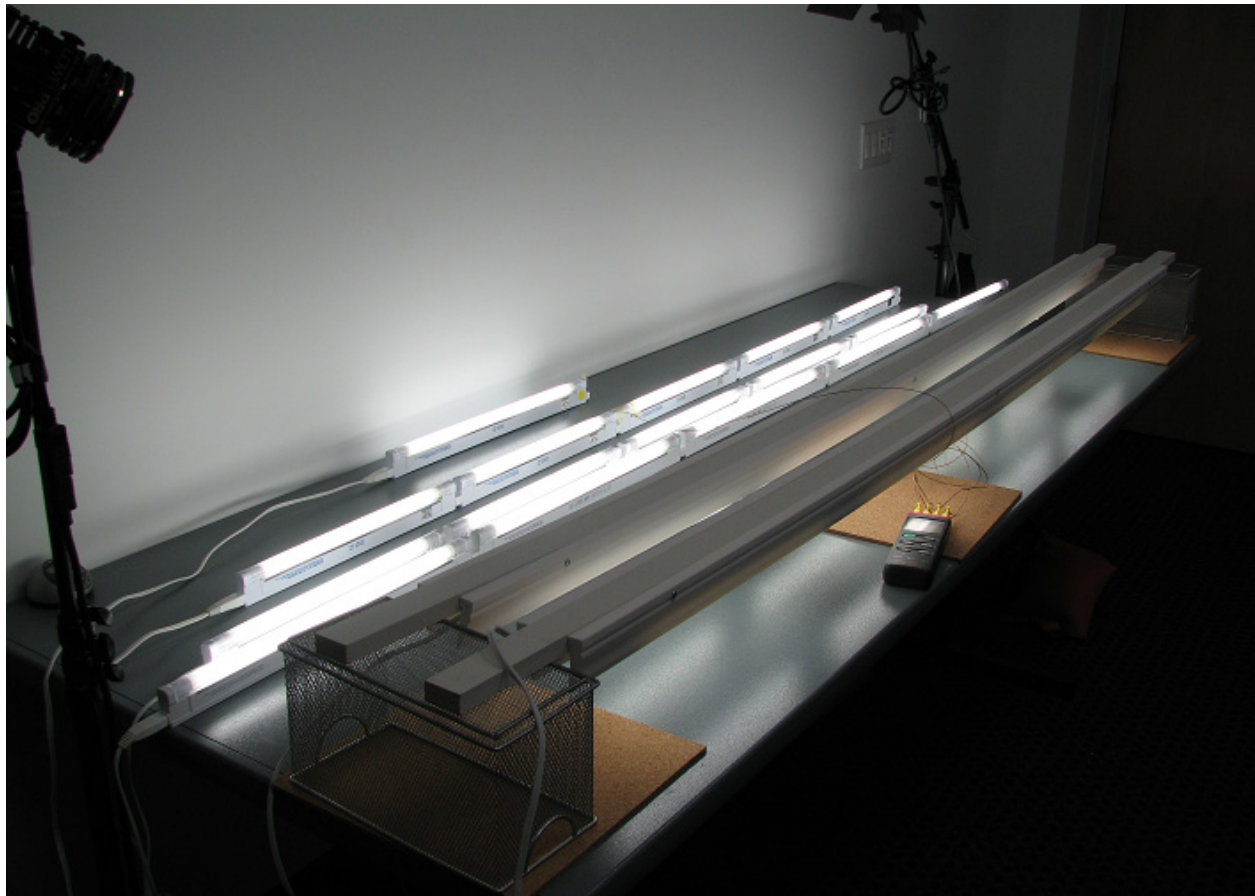
The fixtures were first operated tube-up; thus, the heat of the fluorescent bulbs essentially radiated to the sides or straight up. When installed into appliances such as a salad bar, the fixtures are typically mounted with the tube down inside a metal channel. This allows the bulb heat to rise and surround the fixture itself, heating the whole fixture. After gathering initial temperature data, the test setup was modified with the addition of two custom fabricated “channels” within which fixtures were mounted. These channels were then suspended with the tubes down; see the photo below. It was found that while fixture shroud temperatures did rise when mounted within the channel, the increase was at most several degrees Fahrenheit.
