Introduction:

360° Test Labs has been retained to test and analyze supplied heat activated devices. What follows are the **findings** from our independent analysis:

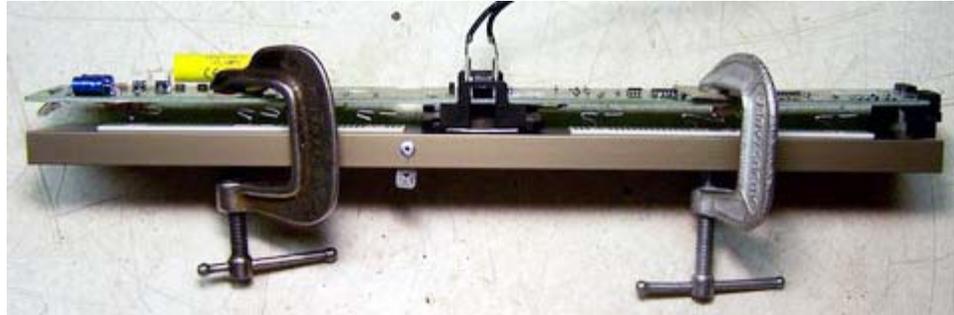
In the device's assembly, it is difficult to measure accurately the element temperatures. Below, the sample was clamped upside down to allow each element's temperature to be measured during operation via an infrared probe.

In testing, the back of the left element would reach 360° F, or even in one case, 388° F, while the front of the hot bar would be 260 and 270°F. At the same time, the right element could get up to 400° F without shutdown, if there was not a good connection to the hot bar.

These very high temperatures could be measured on either heating element side at various times. As noted above, even the controlled left element with its feedback built-in could reach to 388° F (this measurement was made at the element perimeter not from the middle-point). Slow deactivation may be explained by the need for excess heat to migrate to the sensor area, which is located in the middle of the element.

An element on the hot bar with only a 0.001" micro gap on the extremity can reach a temperature > 400° F in that end area with the gap. Clearly, air gap control is crucial to minimizing heating defects. We would expect a major determinant of the longevity of the elements to be the speed at which heat can be transferred from the heating element into the hot bar, and this speed is largely influenced by intimate contact with the hot car.

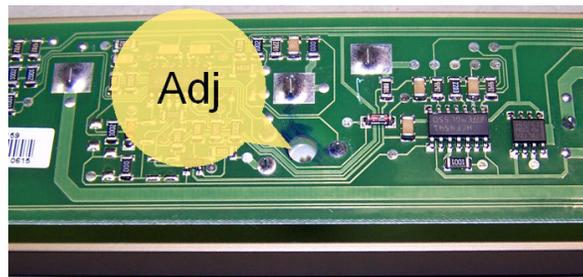
Adjustment Point on the board

On high temperature samples 7 and 8, the adjustment control was turned counter clockwise 1/8 turn at a time, then the device was allowed to run until it reached maximum operating temperature. When the device cooled, if needed, a similar adjustment was again made until the desired 260° F was reached.²

On both of these sample, there were no signs of damage to the PC Board or otherwise that might have caused the faulty temperature settings -- the adjustment control worked as needed.

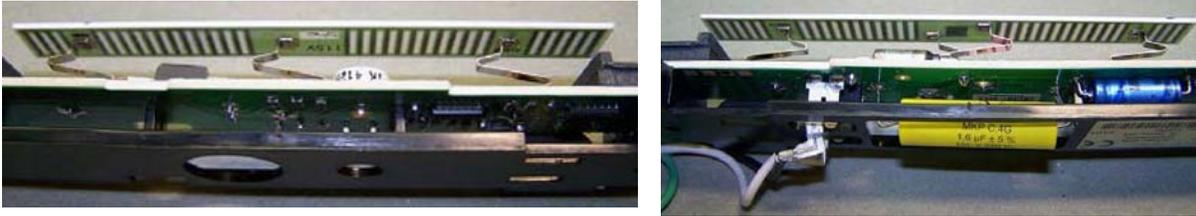
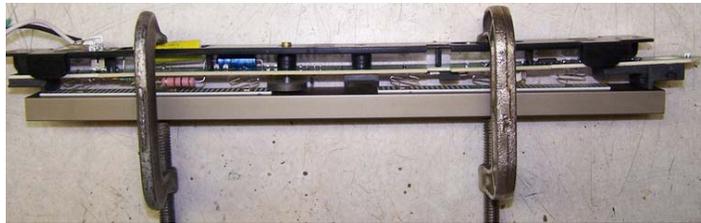
In these samples the heating elements differed from that of the device.

As before, the elements are clamped to the hot bar.

Testing found that the maximum temperature of these elements was 320° F on the left side, and 293° F on the right.³ Whereas the hot bar temperature was 255° F and 245° F respectively. Again, it appeared to take time for heat to travel through the elements substrate, en route to the sensor area. Further, testing suggests that 320° F heat is not overly detrimental to the element,⁴ as this model is not known to have a failure rate paralleling the device. The power draw of this sample was 180-watts on heating that drops to 100-watts while at temperature. Stand by power, as with the device was 7-watts.
