### Introduction

360° Test Labs has been retained to perform hi-pot tests upon two samples of three different gasket materials, as shown in the photo to the right. The materials are labeled ...000, V.. and M... The materials are to be tested to 2500 VDC, and the leakage current must be less than 5 milliamperes.

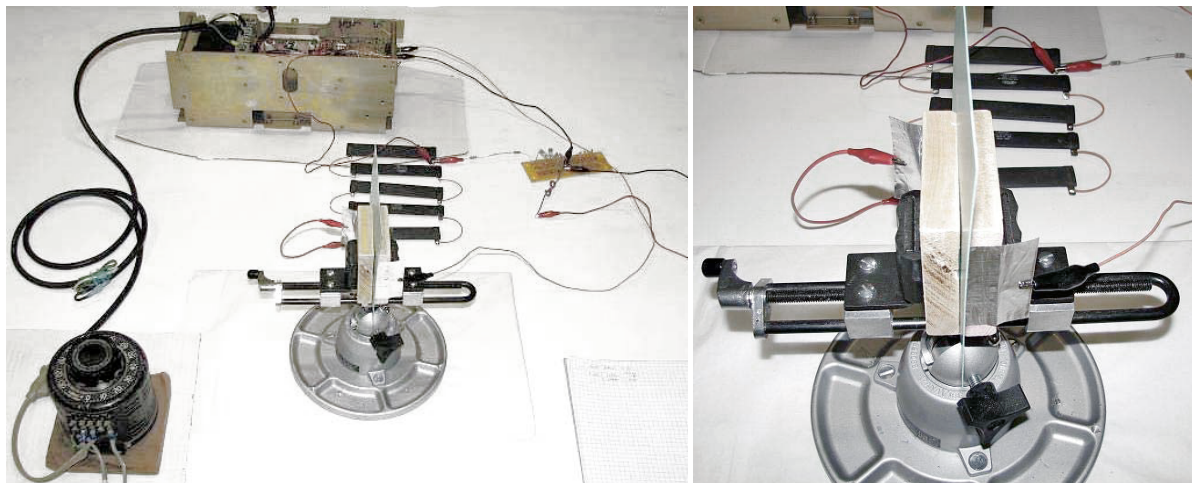
A custom hi-pot test fixture was fabricate specifically for the materials provided. A high-voltage power supply was connected to test probes mounted on each side of each sample, then the voltage was raised to at least 2500 VDC while the leakage current was monitored. Precision digital multimeters were used to perform the voltage and current measurements. The ambient temperature was 77° F and the relative humidity was 28%. The photo below shows the test setup.

The contact patch size on each side of the samples was 2.5" x 3.25", a total area of 8.125 in<sup>2</sup>. The maximum leakage current measured was ~0.1 microamperes at 2500 VDC.
