INTRODUCTION

360° Product Testing has been retained to analyze the design, build and function of the Brand Model 1875W hair dryer. For this purpose a total of twelve driers were supplied (pictured at right), six driers were labeled “fixed” (date coded ...) and six driers were labeled “defective” (date coded ...).

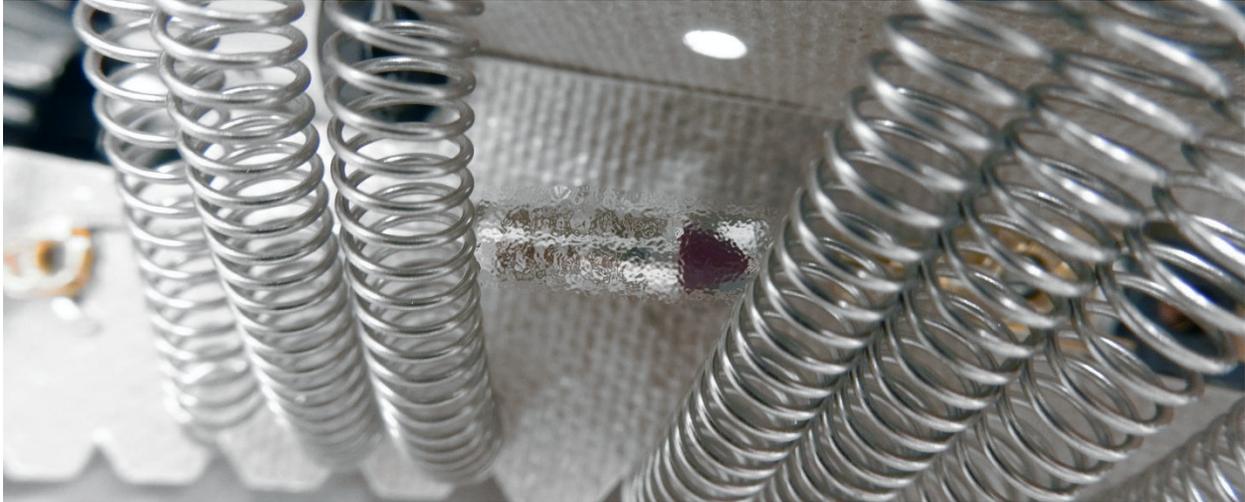
Figure 2: An Brand thermal fuse located within heating element windings

Each dryer labeled “defective” was tested and found to produce no heat. Each of these dryers were then disassembled to isolate the cause of no heat. In all six dryers, it was found that the Brand Model type thermal fuse was open or high resistance. Bypassing this thermal fuse restored the proper function of the defective dryers.

The Brand thermal fuse is marked with a 72°C temperature rating, the datasheet for the fuse states that a 72°C fuse has an operating temperature of 67-71°C.

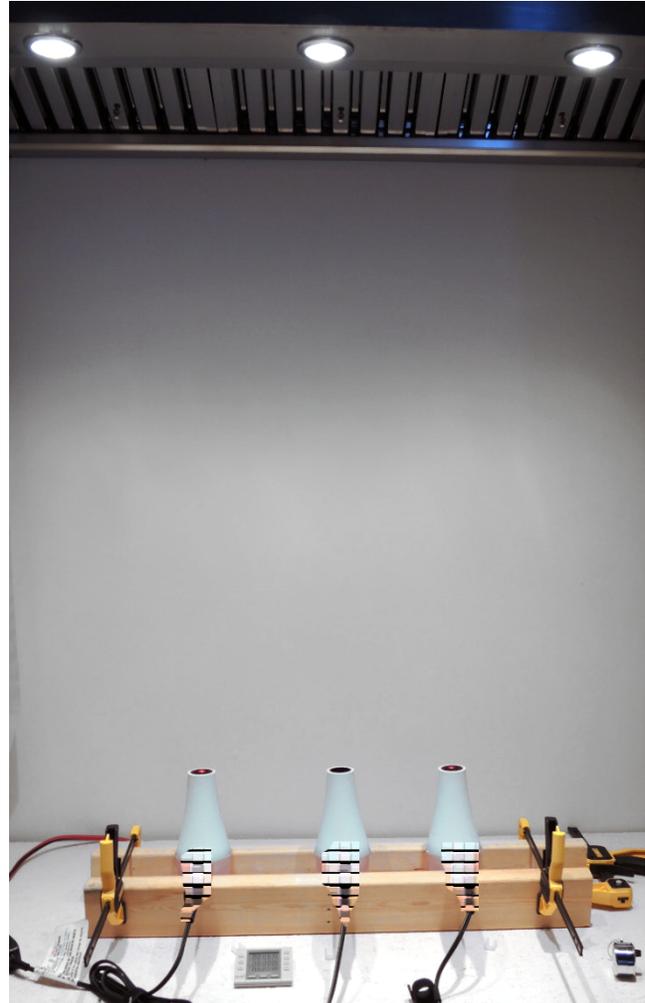
Figure 6: Durability and performance testing setup

In this phase, three of the supplied hair dryers were cycled between a ~ 15-minute period of “ON” status (at high speed and heat) followed by ~15-minutes of “OFF” status. The temperature of each dryer was monitored via thermographic measurements during testing. The dryers were cycled a total of fifty times, one cycle being a single on and off period.

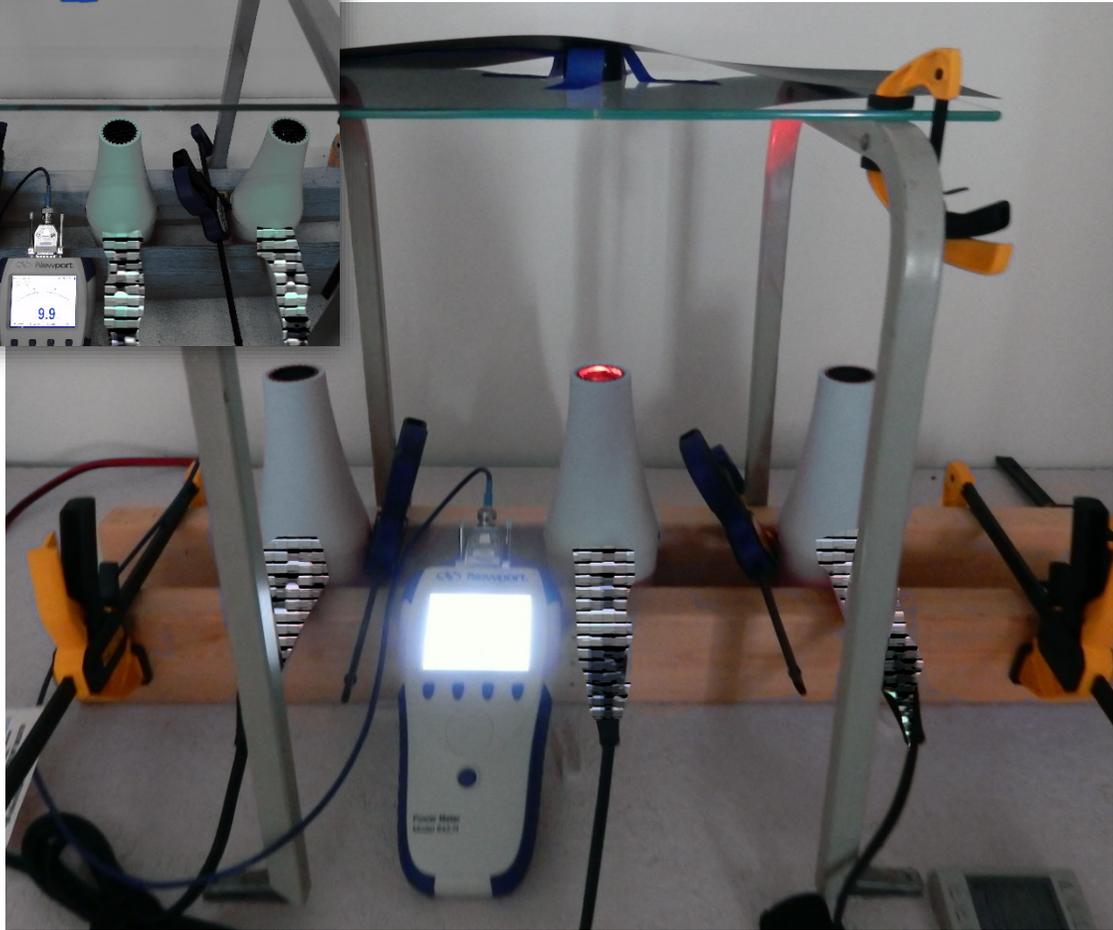
Below – Under infrared test

Measurements of the nominal infrared emissions were taken just after turning the dryer on, then after operating the dryer for two hours. Between those measurements, the emitted infrared varied 0.001mW.
