INTRODUCTION

Failure Investigation

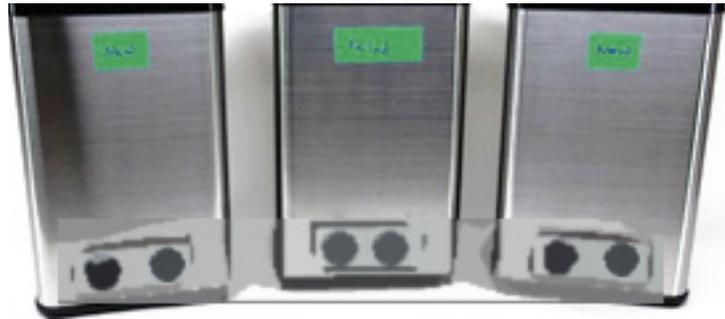
360° has been retained to perform a failure investigation of a supplied medical Heating Unit, and a comparison of 120V and 240V versions. For this purpose, a failed Heating Unit and new Heating Units were supplied as pictured at right.

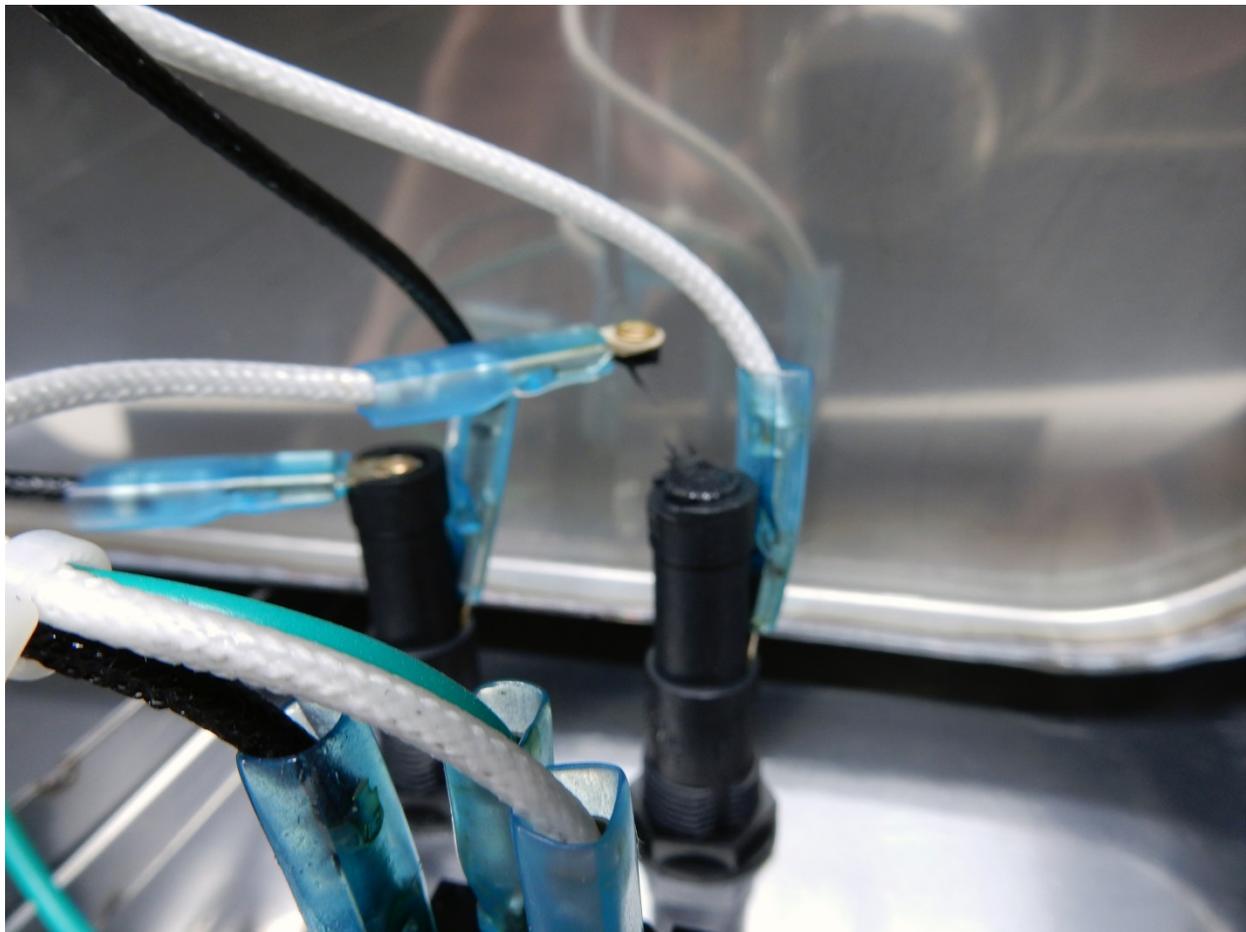
Upon removing the bottom base of the failed Heating Unit, the reason for non-operation was readily apparent; a terminal of the neutral fuse holder had separated from the bottom of the fuse holder.

Figure 1: Terminal detached from neutral fuse holder

Upon close inspection it was noted that the fuse holder showed signs of heat damage in the immediate area where the separated terminal had been attached. The fuse holder was determined to be a Hongju Electronics and Metal Products Co., LTD part number FH201-9-P-W. The datasheet for this fuse holder specifies that it **accepts a 6x30mm fuse**, has a maximum operating temperature of 70°C, and has a current rating of 15 amps.

- The cause of failure of the Medical Heating Unit was likely due to poor contact at the semi-tubular rivet of the fuse holder due to a manufacturing defect. **Failure would be more likely on 120V units due to the higher (double) amperage draw required to produce comparable heating.**
- Compatibility of the fuse holder with 6x32mm fuses should be verified.
- The 120V and 240V Medical Heating Units are nearly identical; as would be expected, the power cord and heating element are different.
- The Medical Heating Units primarily consist of components that are of a generic nature and COTS substitutes for most are available.

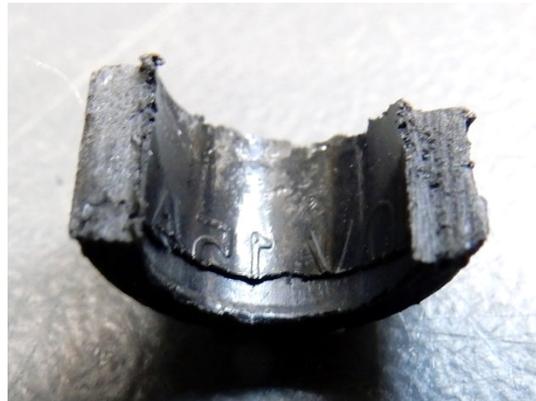
To remove the fuse cap from the fuse holder, it was necessary to cut the fuse holder. When the fuse holder was cut apart, the embossed markings of the fuse cap could clearly be seen in the fuse holder plastic, in addition plastic had flowed between the fuse cap and the contact of the separated terminal; indicating sufficient heat to melt the plastic had occurred.

Figure 2: Embossed markings of fuse cap transferred to plastic of fuse holder (mirrored "0V 15A")

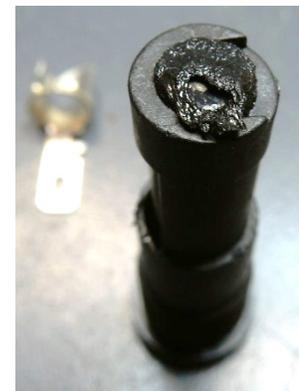
The raw material of the fuse holder, polybutylene terephthalate (PBT), has a melting point of approximately 220°C, far above what the fuse holder would experience during normal operation. The material's thermal characteristics, combined with the highly localized melting of the fuse holder observed, indicates that an extreme temperature rise occurred at the fuse end cap / terminal contact. This temperature rise was likely due to poor contact between the fuse end cap and the terminal contact.

Figure 3: Localized melting of fuse holder

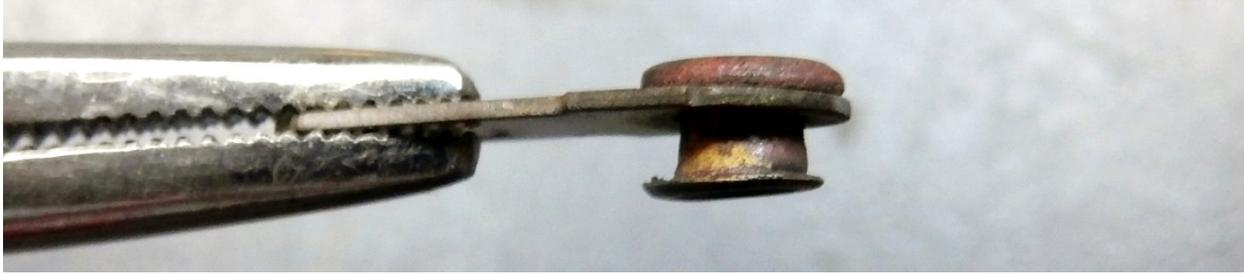
Two possible causes of poor contact are a poorly fitted fuse end cap, or an improperly assembled terminal contact. However, when the fuse was reassembled, the end cap appeared to fit properly. The terminal contact is a semi-tubular rivet, the head of which makes contact with the fuse. The tubular portion at the opposite end is rolled down to fasten the terminal. From side-to-side there was a measured difference between the head and rolled portion of 0.5mm at opposing points around the circumference of the rivet. This may have resulted in a canted head or a poor connection to the terminal; which would cause poor contact and excess heating.

Figure 4: Fuse terminal and semi-tubular rivet
