INTRODUCTION

360° Test Labs has been retained to perform a failure investigation and analysis of Branded Model T8 LEDs that have exhibited a high rate of failures. For this purpose twenty-four failed, and twenty-four new Branded T8 LEDs were supplied (pictured right). The Branded Model is a direct voltage five foot lamp designed to retrofit a florescent fixture after removal of the ballast.

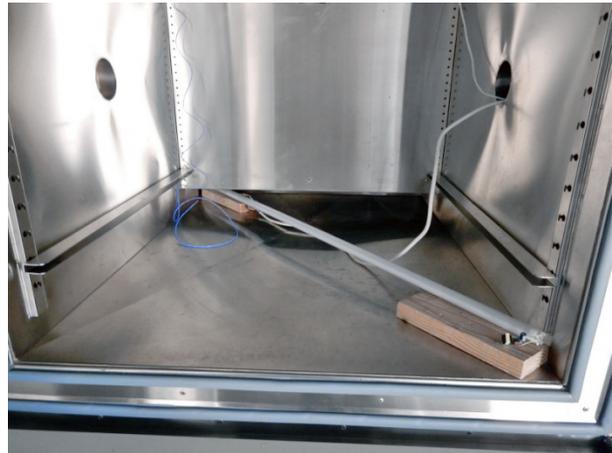
Figure 5: Lamp placed within environmental chamber

A lamp was also placed within an environmental chamber and operated at maximum specified ambient temperature (45°C / 113°F) for an extended time period. Significant heat was generated by the transformer on the driver board, which is adjacent to the R4 resistor. 166°F (75°C), high enough that derating of the resistor is appropriate.

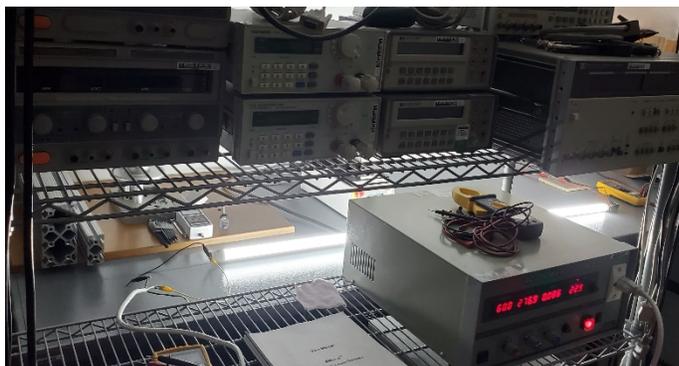
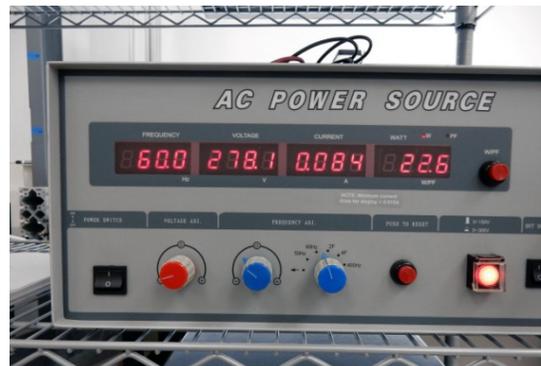
Figure 7: Power source supplying ~277 VAC

A voltage measurement across the R4 resistor with the lamp powered by 120 VAC found an acceptable voltage drop of approximately 92 VDC. Conversely, when powered by 277 VAC this voltage drop increased to approximately 240 VDC; extremely close to the typical 250 volt maximum working voltage of a ¼ watt metal film resistor.
