## Introduction

360° has been retained to conduct performance testing of three “brands” of condensate pumps as shown to the right and listed below:

**“New” P-1-Small Pump Physical and Operational Inspection:**

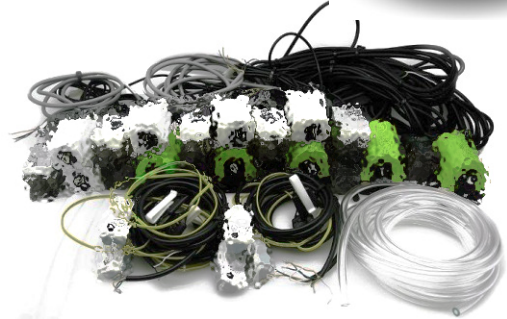
- Switch-1 (SW-1) Condensate Switch
- “New” Pump-1 (P-1) Small Condensate Pump
- Pump-1 (P-1) Small Split Slender Condensate Pump

Both of the pumps are rated to operate on 120 – 240VAC 50 or 60 Hz, while the Switch-1 (SW-1) is rated for use at 18 - 250VAC. The Small Split Slender pump uses a reed type float switch, while the “New” P-1- Small uses an electronic switch with bare probes, both inside a small plastic water tank. The Switch-1 (SW-1) Switch has an electronic moisture sensor as a separate, but attached (hardwired) module. The Switch-1 (SW-1) switches are covered later, beginning on page 6 of this report.

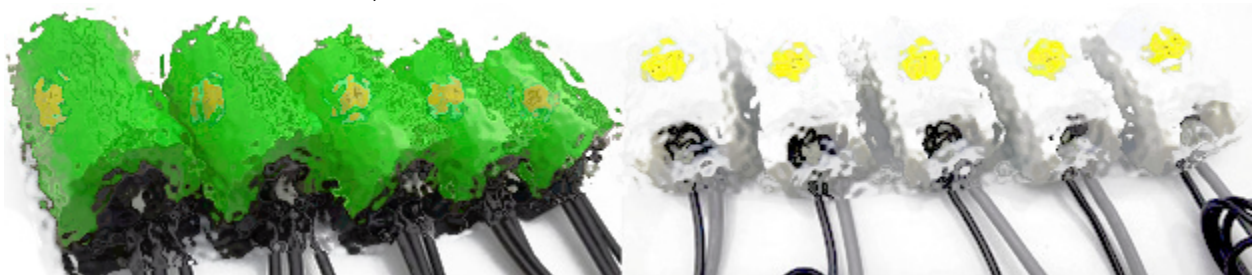
**Figure 1: “New” P-1-Small pumps to the left, Small Split Slender pumps to the right. Each model of pump was randomly numbered 1 through 5 for further identification by 360° Tests Labs.**

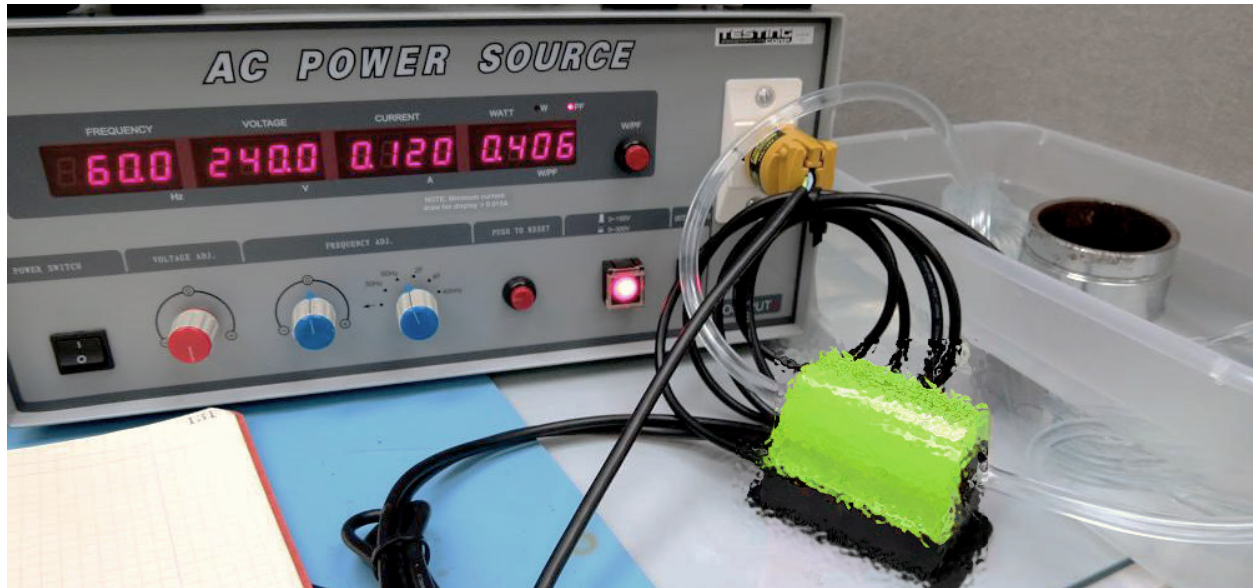
Power was supplied by a YK-BP8102 frequency converter, while current was measured from the front panel of the converter; see the following image.

**Figure 3: A “New” P-1-Small pump under test at 240VAC. Current of the Small pumps tended to fluctuate somewhat; the current observed after several minutes was recorded below in Table 1.**

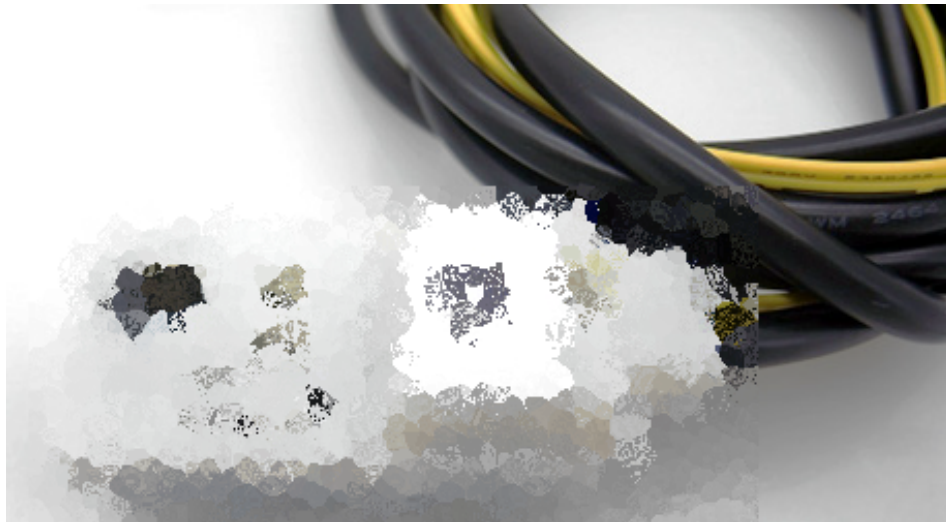
The condensate switch changes the state of a mechanical relay when moisture is detected by the attached sensor. The relay state can also be changed by a “Test” button on the device. The encapsulated printed wire board is encased within a glued plastic housing.

**Figure 4: “Switch-1” (SW-1) Condensate Switch**

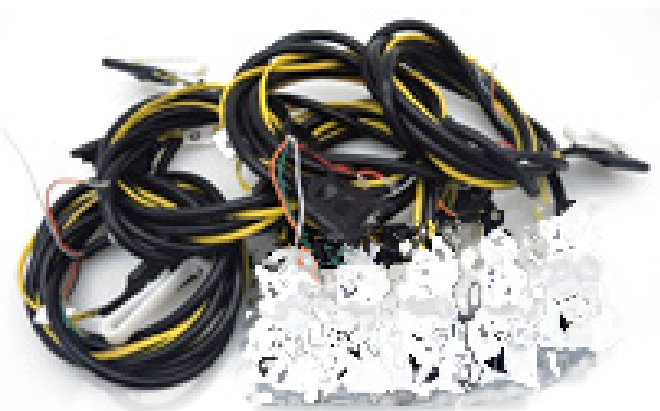
The Switch-1 (SW-1) switches were powered with 4 voltages from 18 to 48 volts (18, 24, 36 and 48), six voltages from 90 to 140 volts (90, 100, 110, 120, 130 and 140) and five voltages from 210 to 250 volts (210, 220, 230, 240 and 250) at both 50Hz and 60 Hz.

Power was supplied by a YK-BP8102 frequency converter, current was measured by a HP/Agilent 3457A digital multi-meter, and relay state was monitored with a HP/Agilent 3468A digital multi-meter.

Power consumption at 60Hz was slightly higher than 50Hz at all voltages. The maximum current draw was found to occur when the relay was energized; i.e., the “run” state. In the “run” state, the power consumption varied from a high of approximately 10 mA @ 250VAC (2.5 watts) to a low of approximately 13.1 mA @ 18VAC (0.24 watts). In the “alarm” state, the power consumed was significantly lower, ranging from a high of approximately 4.5 mA @ 250VAC (1.13 watts) to a low of approximately 3.0 mA @ 18VAC (0.05 watts).

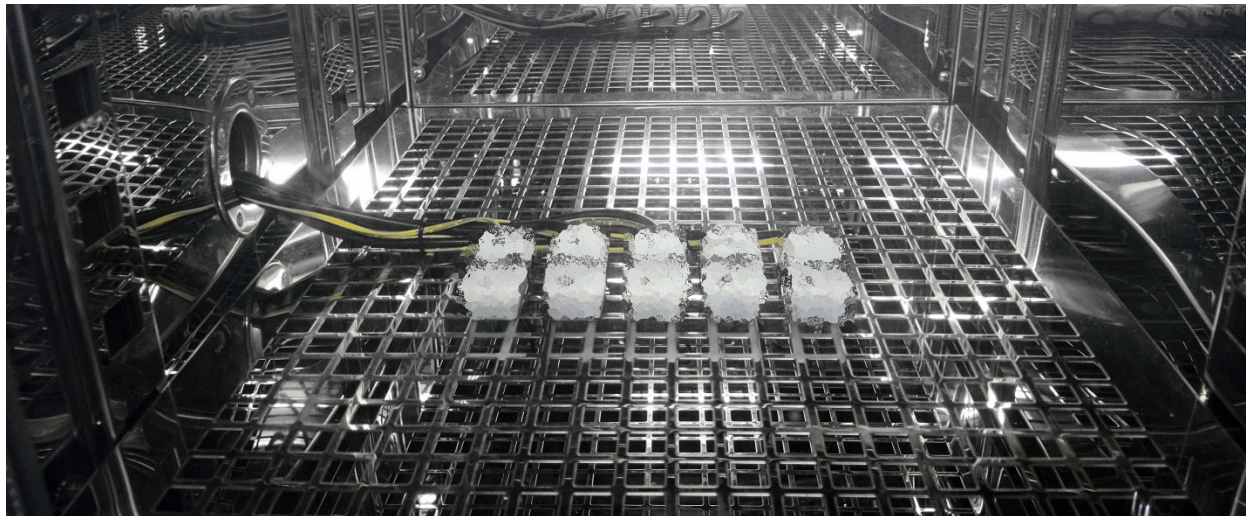
The Switch-1 (SW-1) Switches were placed within a YTH-225-70-1P environmental chamber for determination of temperature sensitivity. The leads of each Switch-1 (SW-1) were passed through the chamber wall where power was applied, moisture stimulus provided, and relay function verified.

Figure 2: Switch-1es (SW-1) fixtured within an environmental chamber ("A"-"E", left to right)

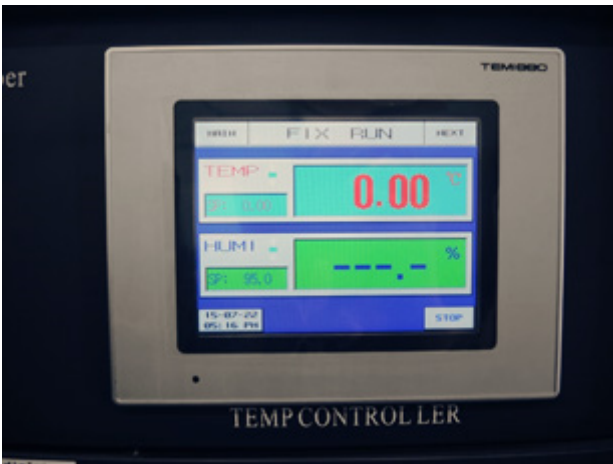
**Figure 4: Thermal chamber @ 0°C**

Power was applied to the switches by a conventional 120VAC 60Hz electrical receptacle and the environment in the thermal chamber was lowered to 0°C (32°F). The chamber environment was maintained at 0°C for one hour before functionality of the switches was tested. The Switch-1es (SW-1), except for "C" & "E", operated normally when a moisture stimulus was applied.

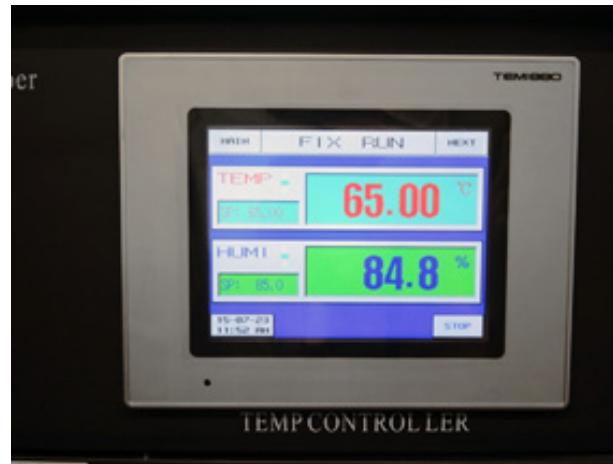
**Figure 5: Thermal chamber @ 65°C, 85% RH**

The environment in the chamber was then raised to +65°C (149°F) @ 85% relative humidity that was maintained for one hour before testing the functionality of the Switch-1es (SW-1). In this environment, all of the switches properly responded to a moisture stimulus and switched to the “alarm” state where they remained until the moisture stimulus was removed.

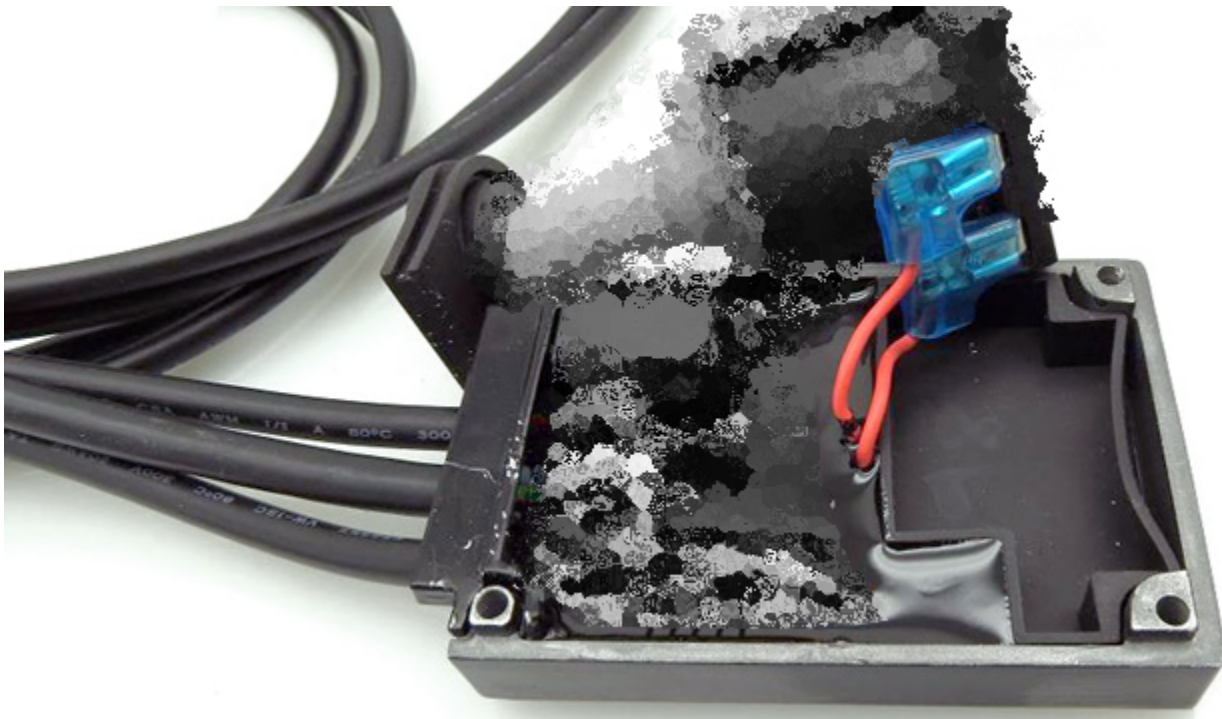
The following image shows the internal construction of the "New" P-1-Small pump, including the potted PC board. The potting compound appears to be a hard-setting black plastic.

Figure 11: Internal construction of "New" P-1-Small pump. A rubber grommet has been removed from the right side of the pump during disassembly.
