## Introduction:

360° Test Labs has been retained to ascertain whether certain circuitry changes to fluorescent lamp electronic ballasts reduce or eliminate an overheating problem whereby a plastic shroud over the lamps melts at the ends of the lamps.

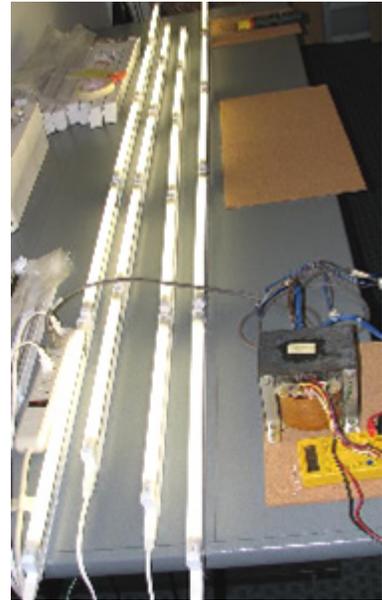
Initially, all twenty fixtures were operated continuously, without power cycling, for 8 hours (pictured at right). The transformer stepped up 120VAC to 240VAC.

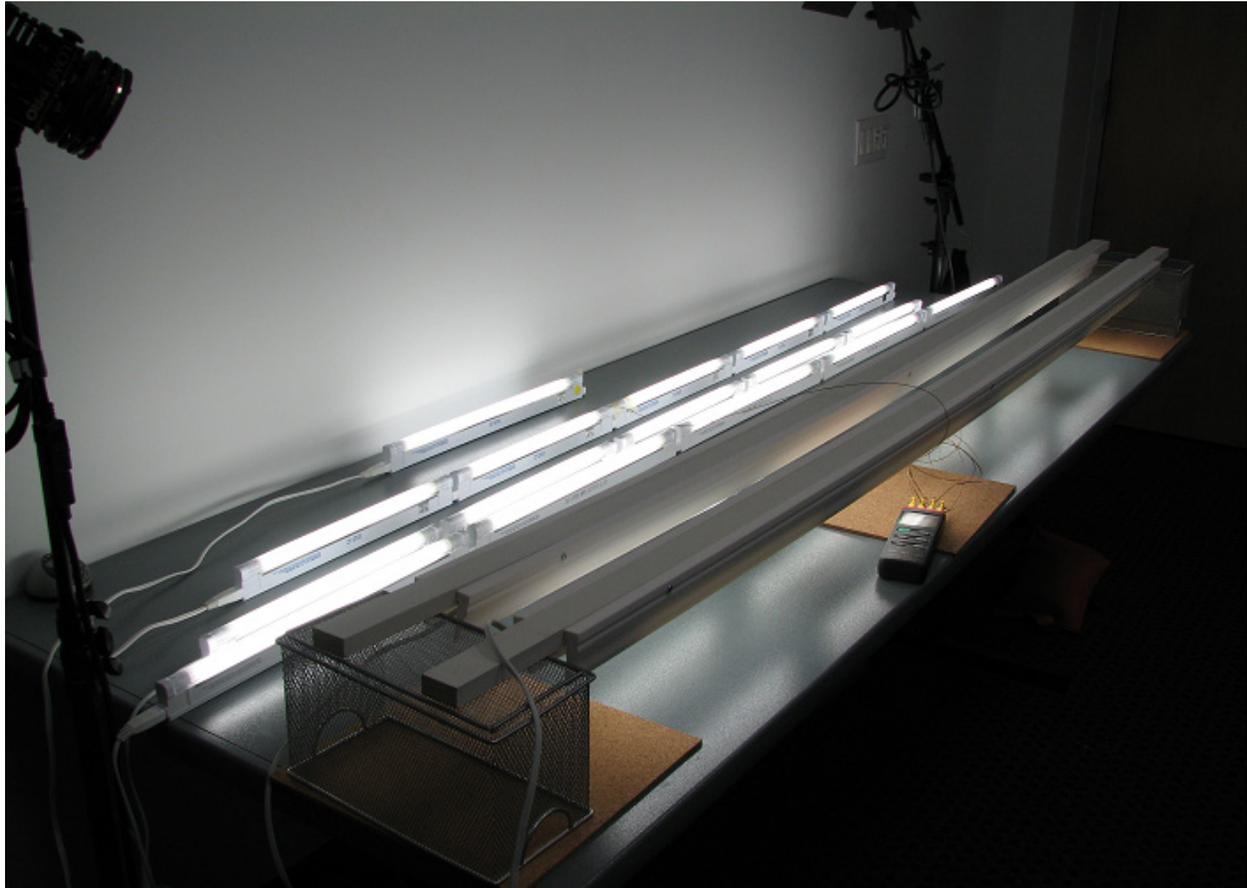
The fixtures were first operated tube-up; thus, the heat of the fluorescent bulbs essentially radiated to the sides or straight up. When installed into appliances such as a salad bar, the fixtures are typically mounted with the tube down inside a metal channel. This allows the bulb heat to rise and surround the fixture itself, heating the whole fixture. After gathering initial temperature data, the test setup was modified with the addition of two custom fabricated “channels” within which fixtures were mounted. These channels were then suspended with the tubes down; see the photo below. It was found that while fixture shroud temperatures did rise when mounted within the channel, the increase was at most several degrees Fahrenheit.

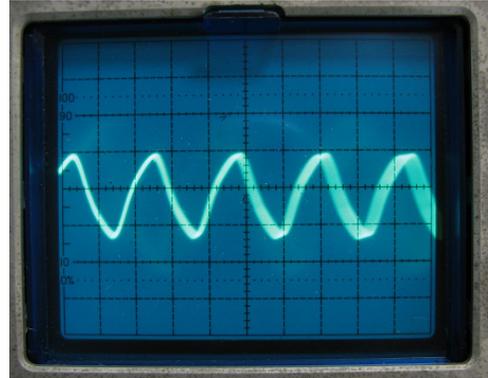
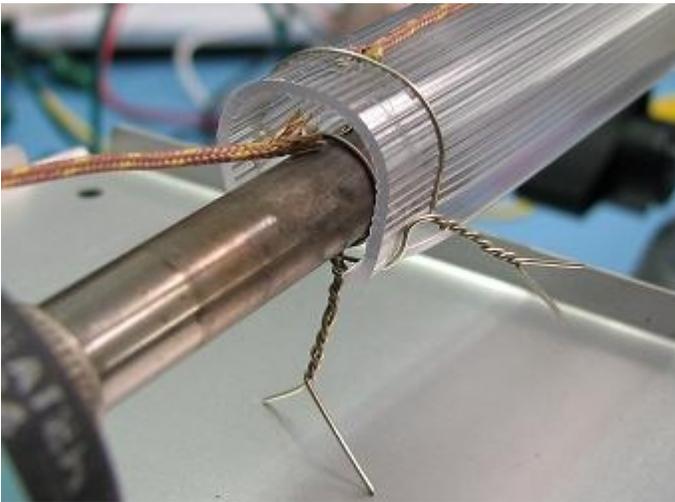
An oscilloscope was used to examine the waveform of an operating 120 VAC, 12W ballast. The multivibrator operates at about 45 kHz and produces an almost-triangle wave; see the photo to the right. The amplitude of the high voltage triangle wave applied to a lit 12W tube is approximately 200 volts peak-to-peak (Vpp). As a tube is being ignited, the voltage rises to 700 Vpp (800 Vpp when one filament is shorted). This immediately drops to 200 Vpp after the tube has fired.
