INTRODUCTION

Using custom test fixtures, precision DC high-voltage power supplies, voltmeters and microammeters, 360° Test Labs performed hi-pot (spark) testing upon a spool of copperweld wire (copper-plated hard-drawn steel wire) consisting of three lengths soldered one to another. The individual wire lengths were about 669 feet, 732 feet and 1330 feet long. The wire has an insulation similar to that found on “magnet wire”, and the purpose of the hi-pot tests was to confirm the wire insulation would withstand 1000 volts DC.

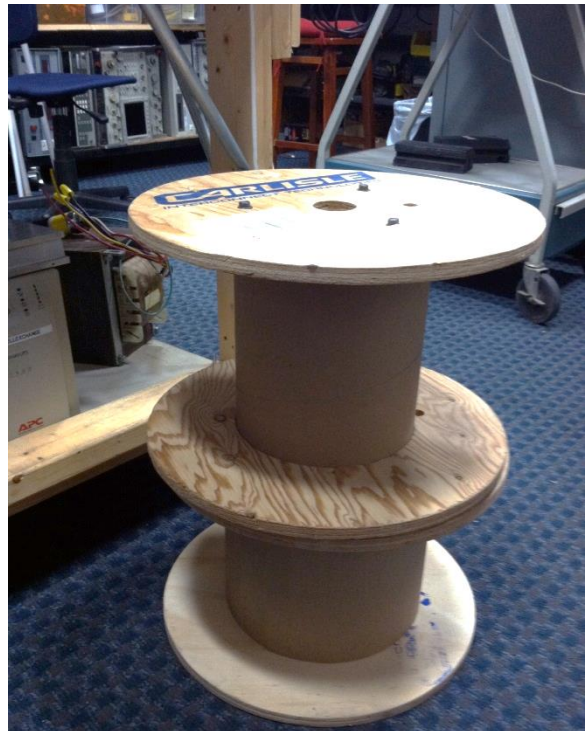
As received, the wire appeared to have imperfections throughout its length, highlighted within the red ovals in the following image. In addition to the visible marks, the insulation coverage of the wire felt rough to the touch. The original spool of wire is seen to the left, while the right spool holds wire that has been rewound onto a provided extra spool during the hi-potting tests.

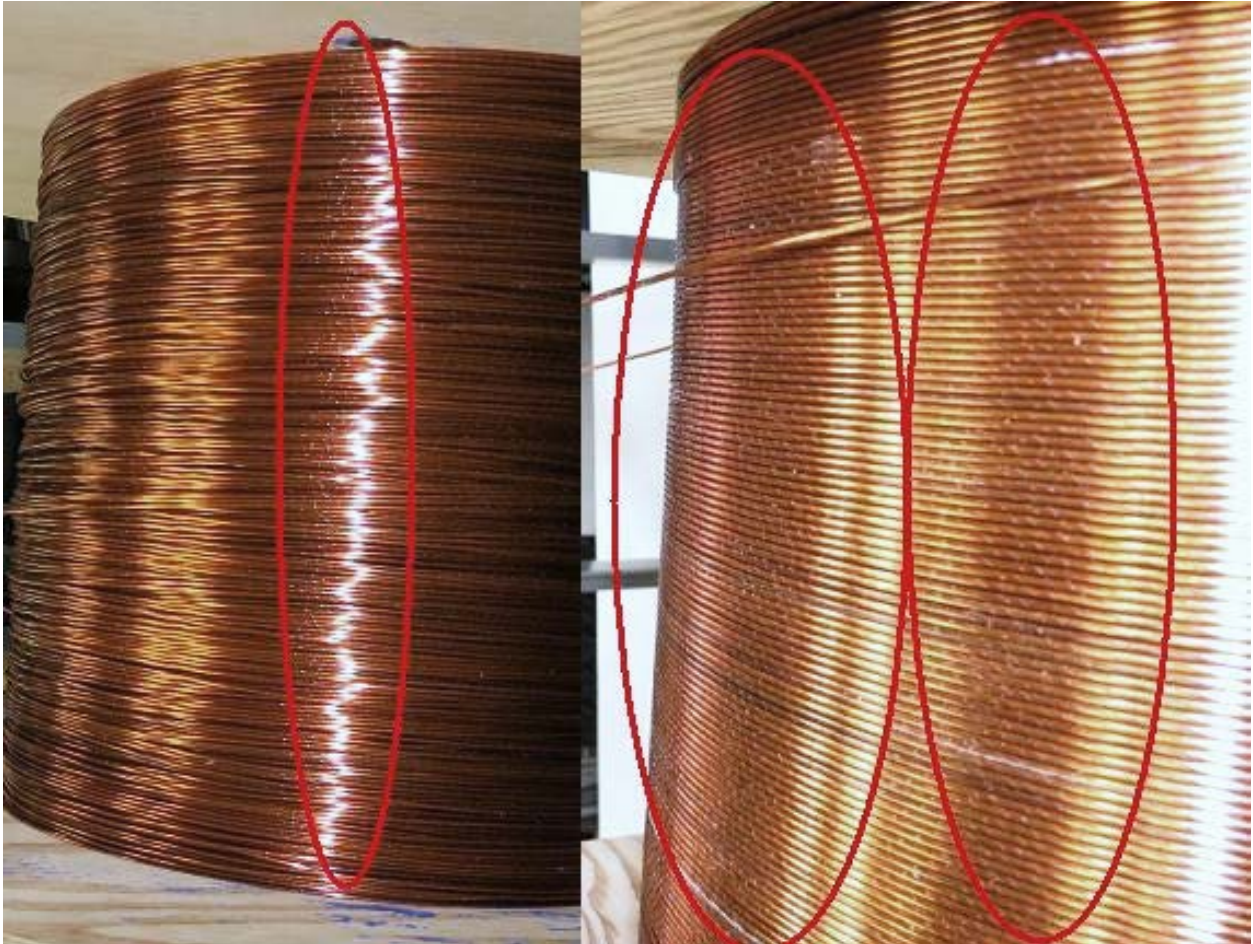
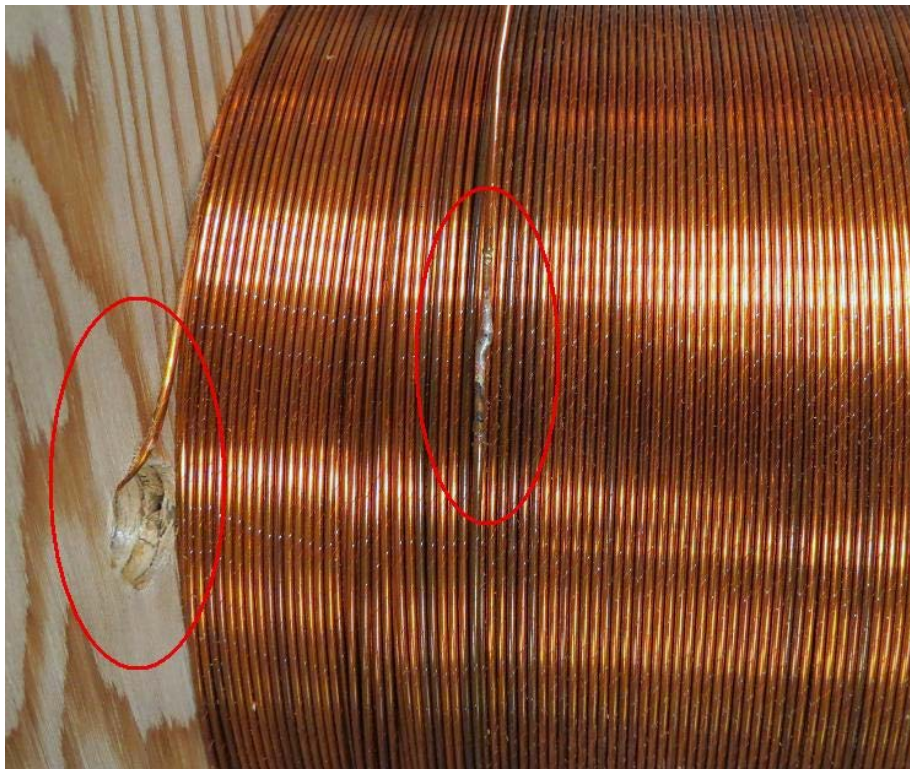
Using a custom-built spool-to-spool winding test fixture, a metallic brush assembly at 1,000 volts DC was allowed to brush against the surface of the wire while a microammeter measured leakage current. Current was limited to 110 microamperes maximum to prevent catastrophic damage to the wire in the event of a high voltage breakthrough. In order to obtain continuous contact with the wire, one end of the wire was threaded through a hole in the spool then clamped under a large steel washer over a threaded rod used as a spindle to allow the wire to unwind one from one spool and onto the other spool. This end of the wire was then grounded. The leftmost red oval in the second image below shows the wire being threaded through the hole in the spool.

The wire insulation proved to survive 1,000 volts DC throughout the length of the insulated wire, other than at the exposed ends. The exposed ends of the three lengths of insulated wire had been soldered together, as seen highlighted to the right in the second image below.
