INTRODUCTION:

360° had been retain to measure and/or characterize meaningful changes of electrical resistance of two supplied pipe samples as outlined below:

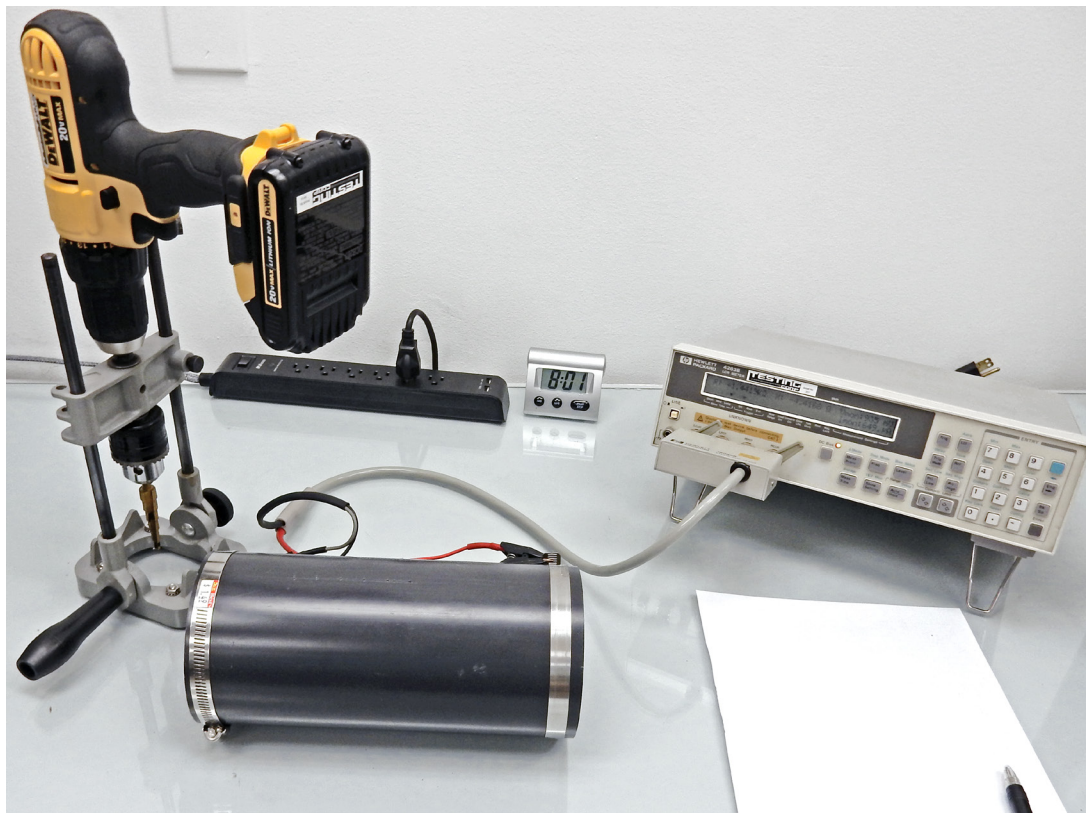
For this purpose, two lengths of pipe approximately 12" long x 4.5" in diameter were supplied. Measurements were obtained by first attaching band electrodes to each pipe end to which the leads of an Agilent 4263B LCR meter were attached. The initial hole drilled in each pipe was 5mm, increasing in 5mm increments to 20mm; subsequent 20mm holes were drilled 15mm center-to-center either transversely or longitudinal to the pipe for a ~ 3" spread first to last.²

Figure 1: Test Configuration

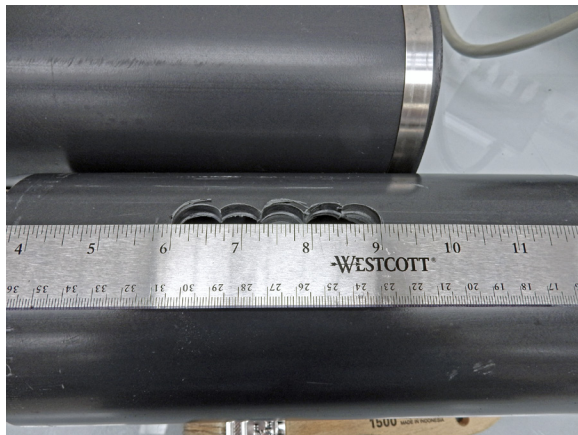
Figure 2: Longitudinally drilled pipe

Hole	R (KΩ)	R (KΩ)	R (KΩ)	Avg Ω	Std Dev
none	1.4427	1.4420	1.4418	1442.17	0.473
5mm	1.4577	1.4575	1.4569	1457.37	0.416
10mm	1.4495	1.4486	1.4478	1448.63	0.850
15mm	1.4285	1.4251	1.4212	1424.93	3.653
20mm	1.4282	1.4247	1.4210	1424.63	3.600
#2	1.3981	1.3962	1.3939	1396.07	2.103
#3	1.3861	1.3849	1.3838	1384.93	1.150
#4	1.3728	1.3719	1.3712	1371.97	0.802
#5	1.3599	1.3593	1.3574	1358.87	1.305

Table 2: Longitudinal resistance measurements

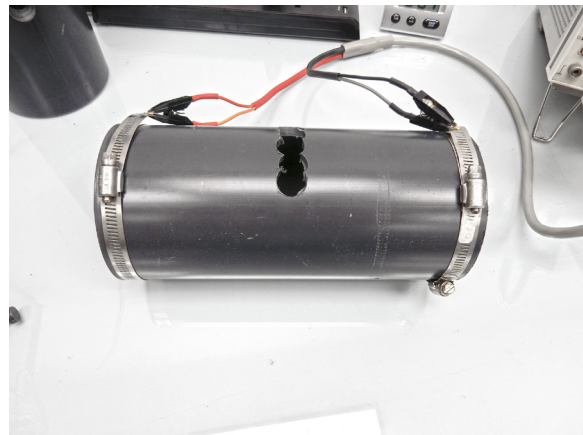
Figure 3: Transversely drilled pipe

Hole	R (KΩ)	R (KΩ)	R (KΩ)	Avg Ω	Std Dev
none	1.1953	1.1948	1.1944	1194.83	1.150
5mm	1.2457	1.2461	1.2464	1246.07	0.351
10mm	1.3227	1.3032	1.2756	1300.50	23.666
15mm	1.2352	1.2337	1.2328	1233.90	1.212
20mm	1.1956	1.1948	1.1944	1194.93	0.611
#2	1.4741	1.4299	1.3857	1429.90	44.200
#3	1.3386	1.3356	1.3309	1335.03	3.881
#4	1.3918	1.3851	1.3762	1384.37	7.826
#5	1.4465	1.4453	1.4442	1445.33	1.150

Table 1: Transverse resistance measurements
